**D R A F T Preliminary  
Environmental Assessment  
Work Plan**  
Juan Cabrillo Elementary School and  
Malibu Middle and High Schools  
30237 and 30215 Morning View Drive  
Malibu, California

Prepared for:  
**Santa Monica-Malibu United School District**  
**Santa Monica, California**

Prepared by:  
**ENVIRON International Corporation**  
**Irvine, California**

Date:  
**May 23, 2014**

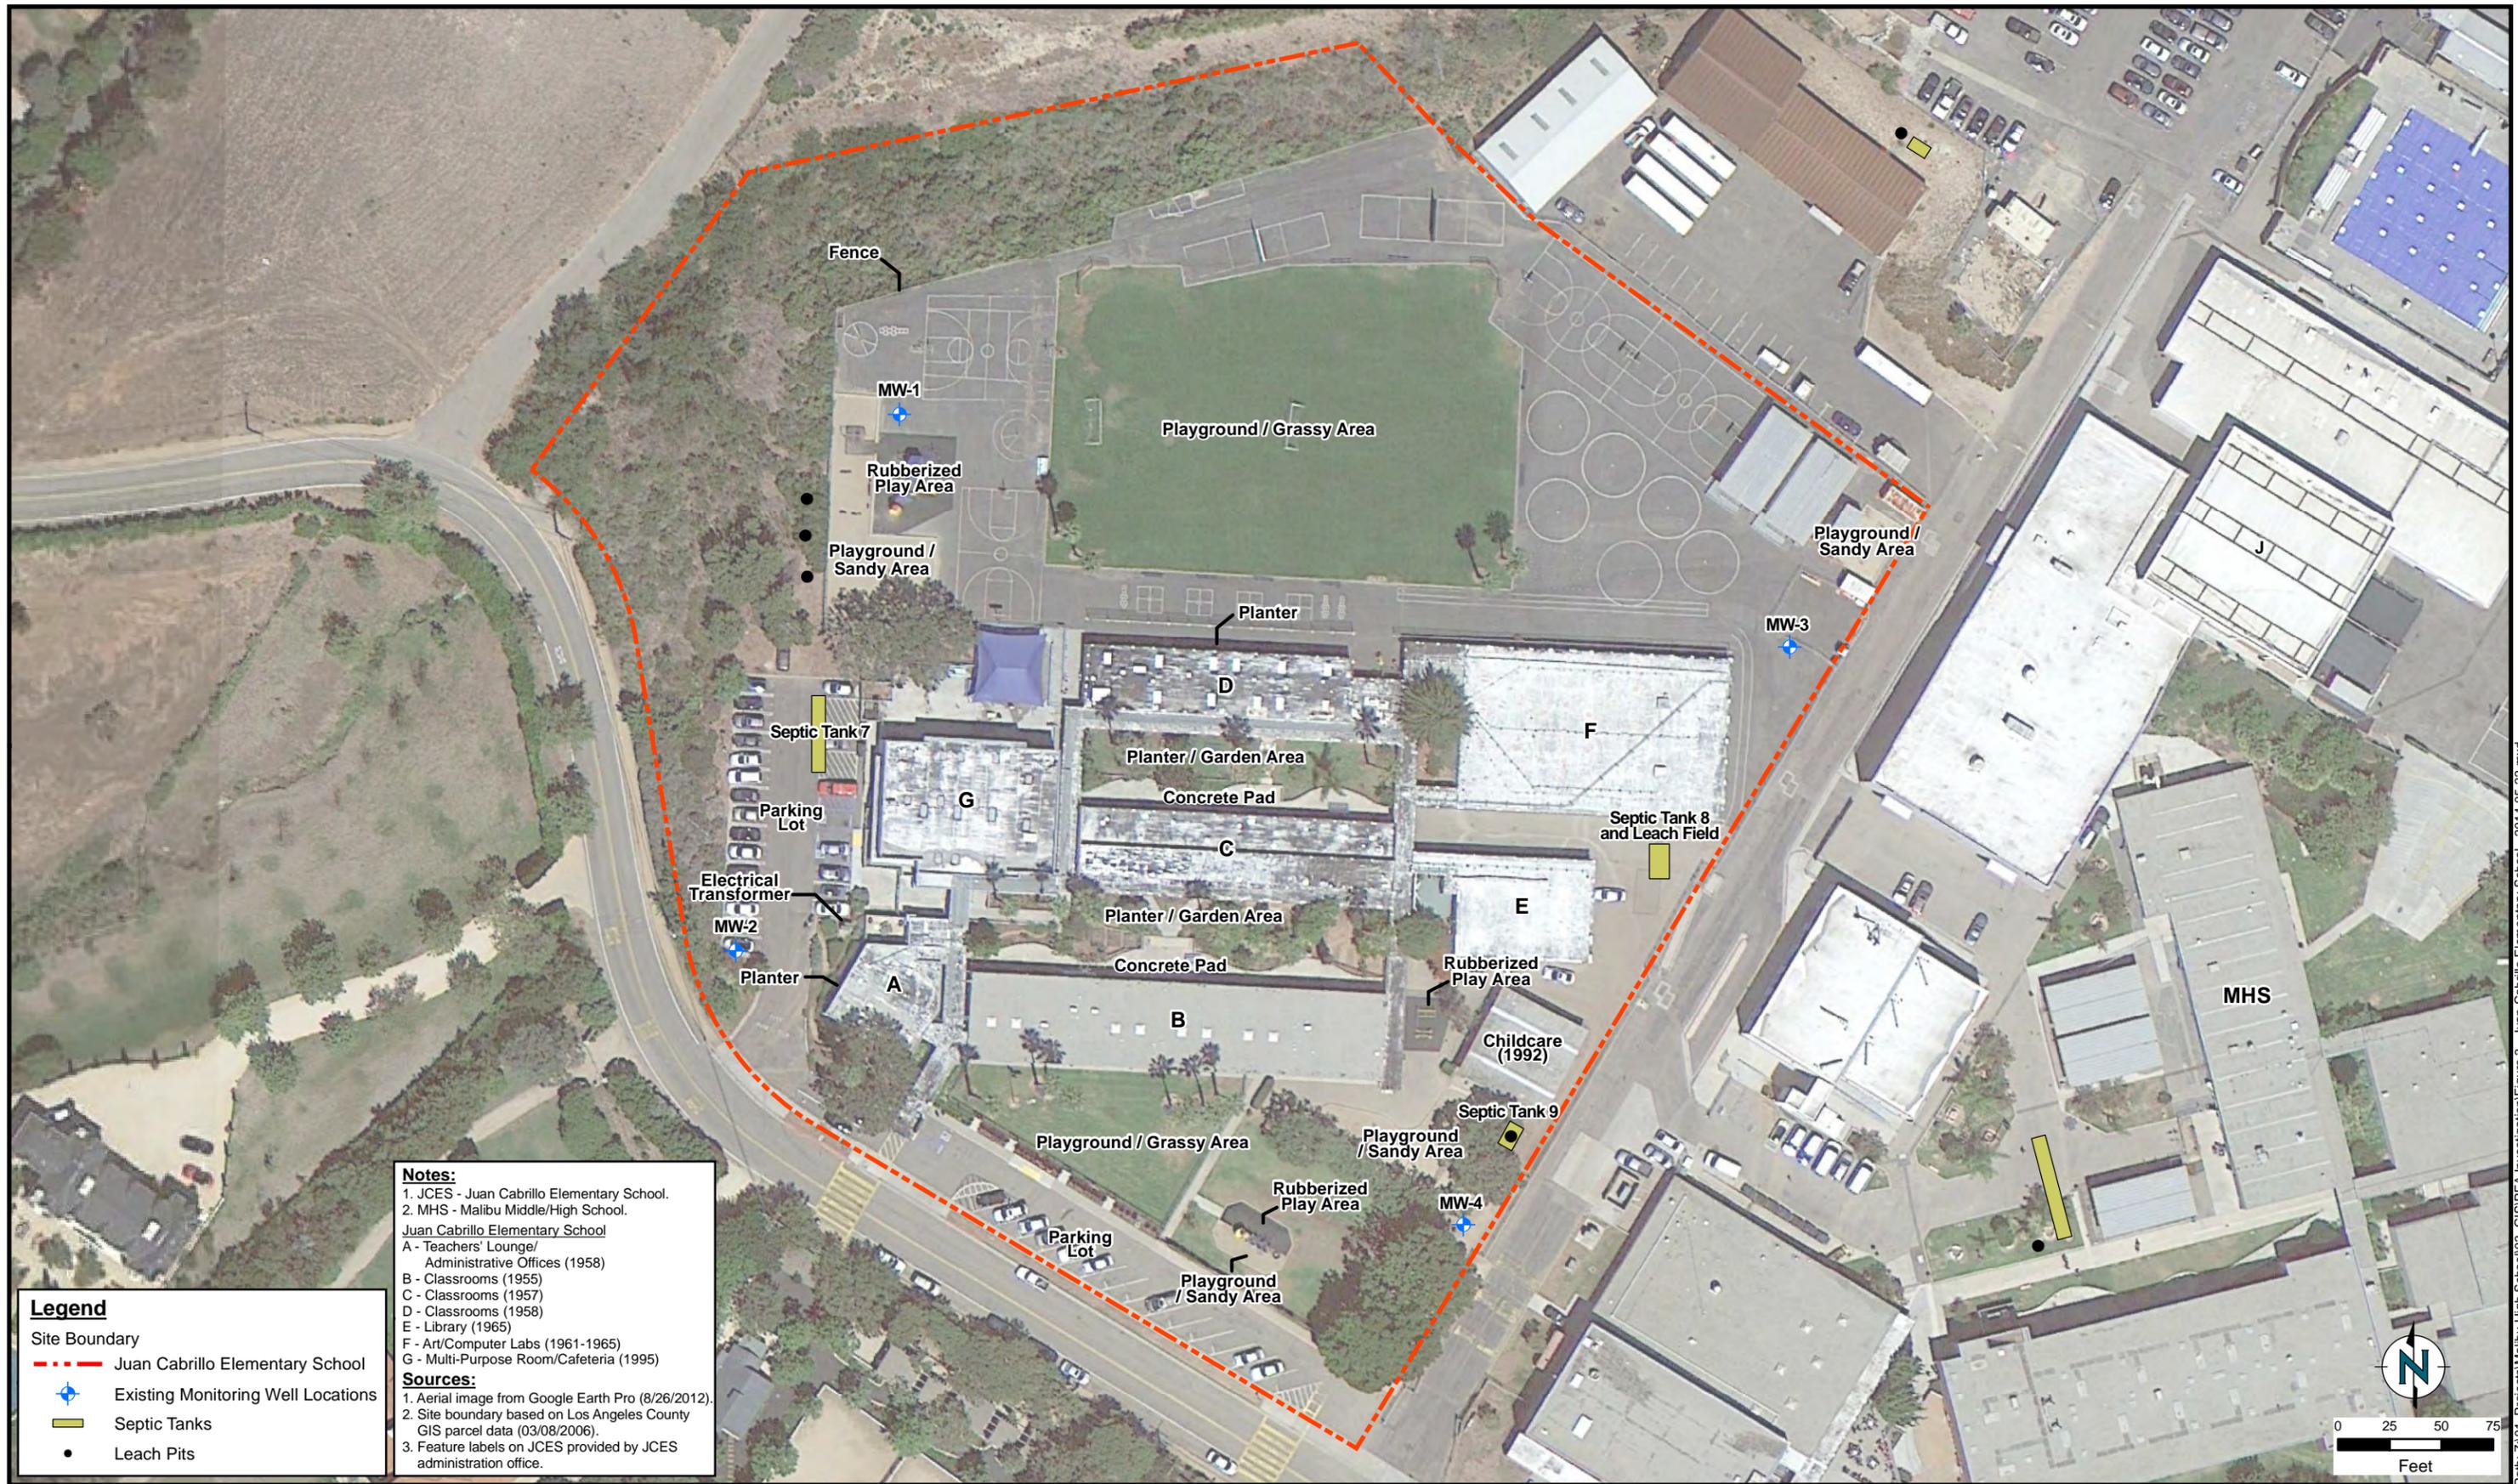
Path: Z:\01\_Projects\Malibu High School\03\_GIS\PEA Investigation\Figure 3 - Juan Cabrillo Elementary School - 2014-05-22.mxd

**Legend**  
 Site Boundary  
 - - - Juan Cabrillo Elementary School  
 Existing Monitoring Well Locations  
 Septic Tanks  
 Leach Pits

ENVIRON walked the entire school and observed both the exteriors and interiors of the buildings. Areas around the buildings typically are bordered with an approximate 8- to 10-foot wide concrete walkway and a concrete and/or vinyl siding overhang. Buildings A and D are bordered by a planter to the south and to the north, respectively. ENVIRON observed the playgrounds (grassy play area and adjacent sandbox playground) and the interior garden areas located between Buildings B, C, and D, as depicted on Figure 3.

Three septic tank areas that service JCES (Septic Tanks 7, 8, and 9) were observed. Septic Tank 7 is located in the northern end of the staff parking and is connected to three leach pits; Septic Tank 8 is located south of Building F and is connected to a leach field; and Septic Tank 9

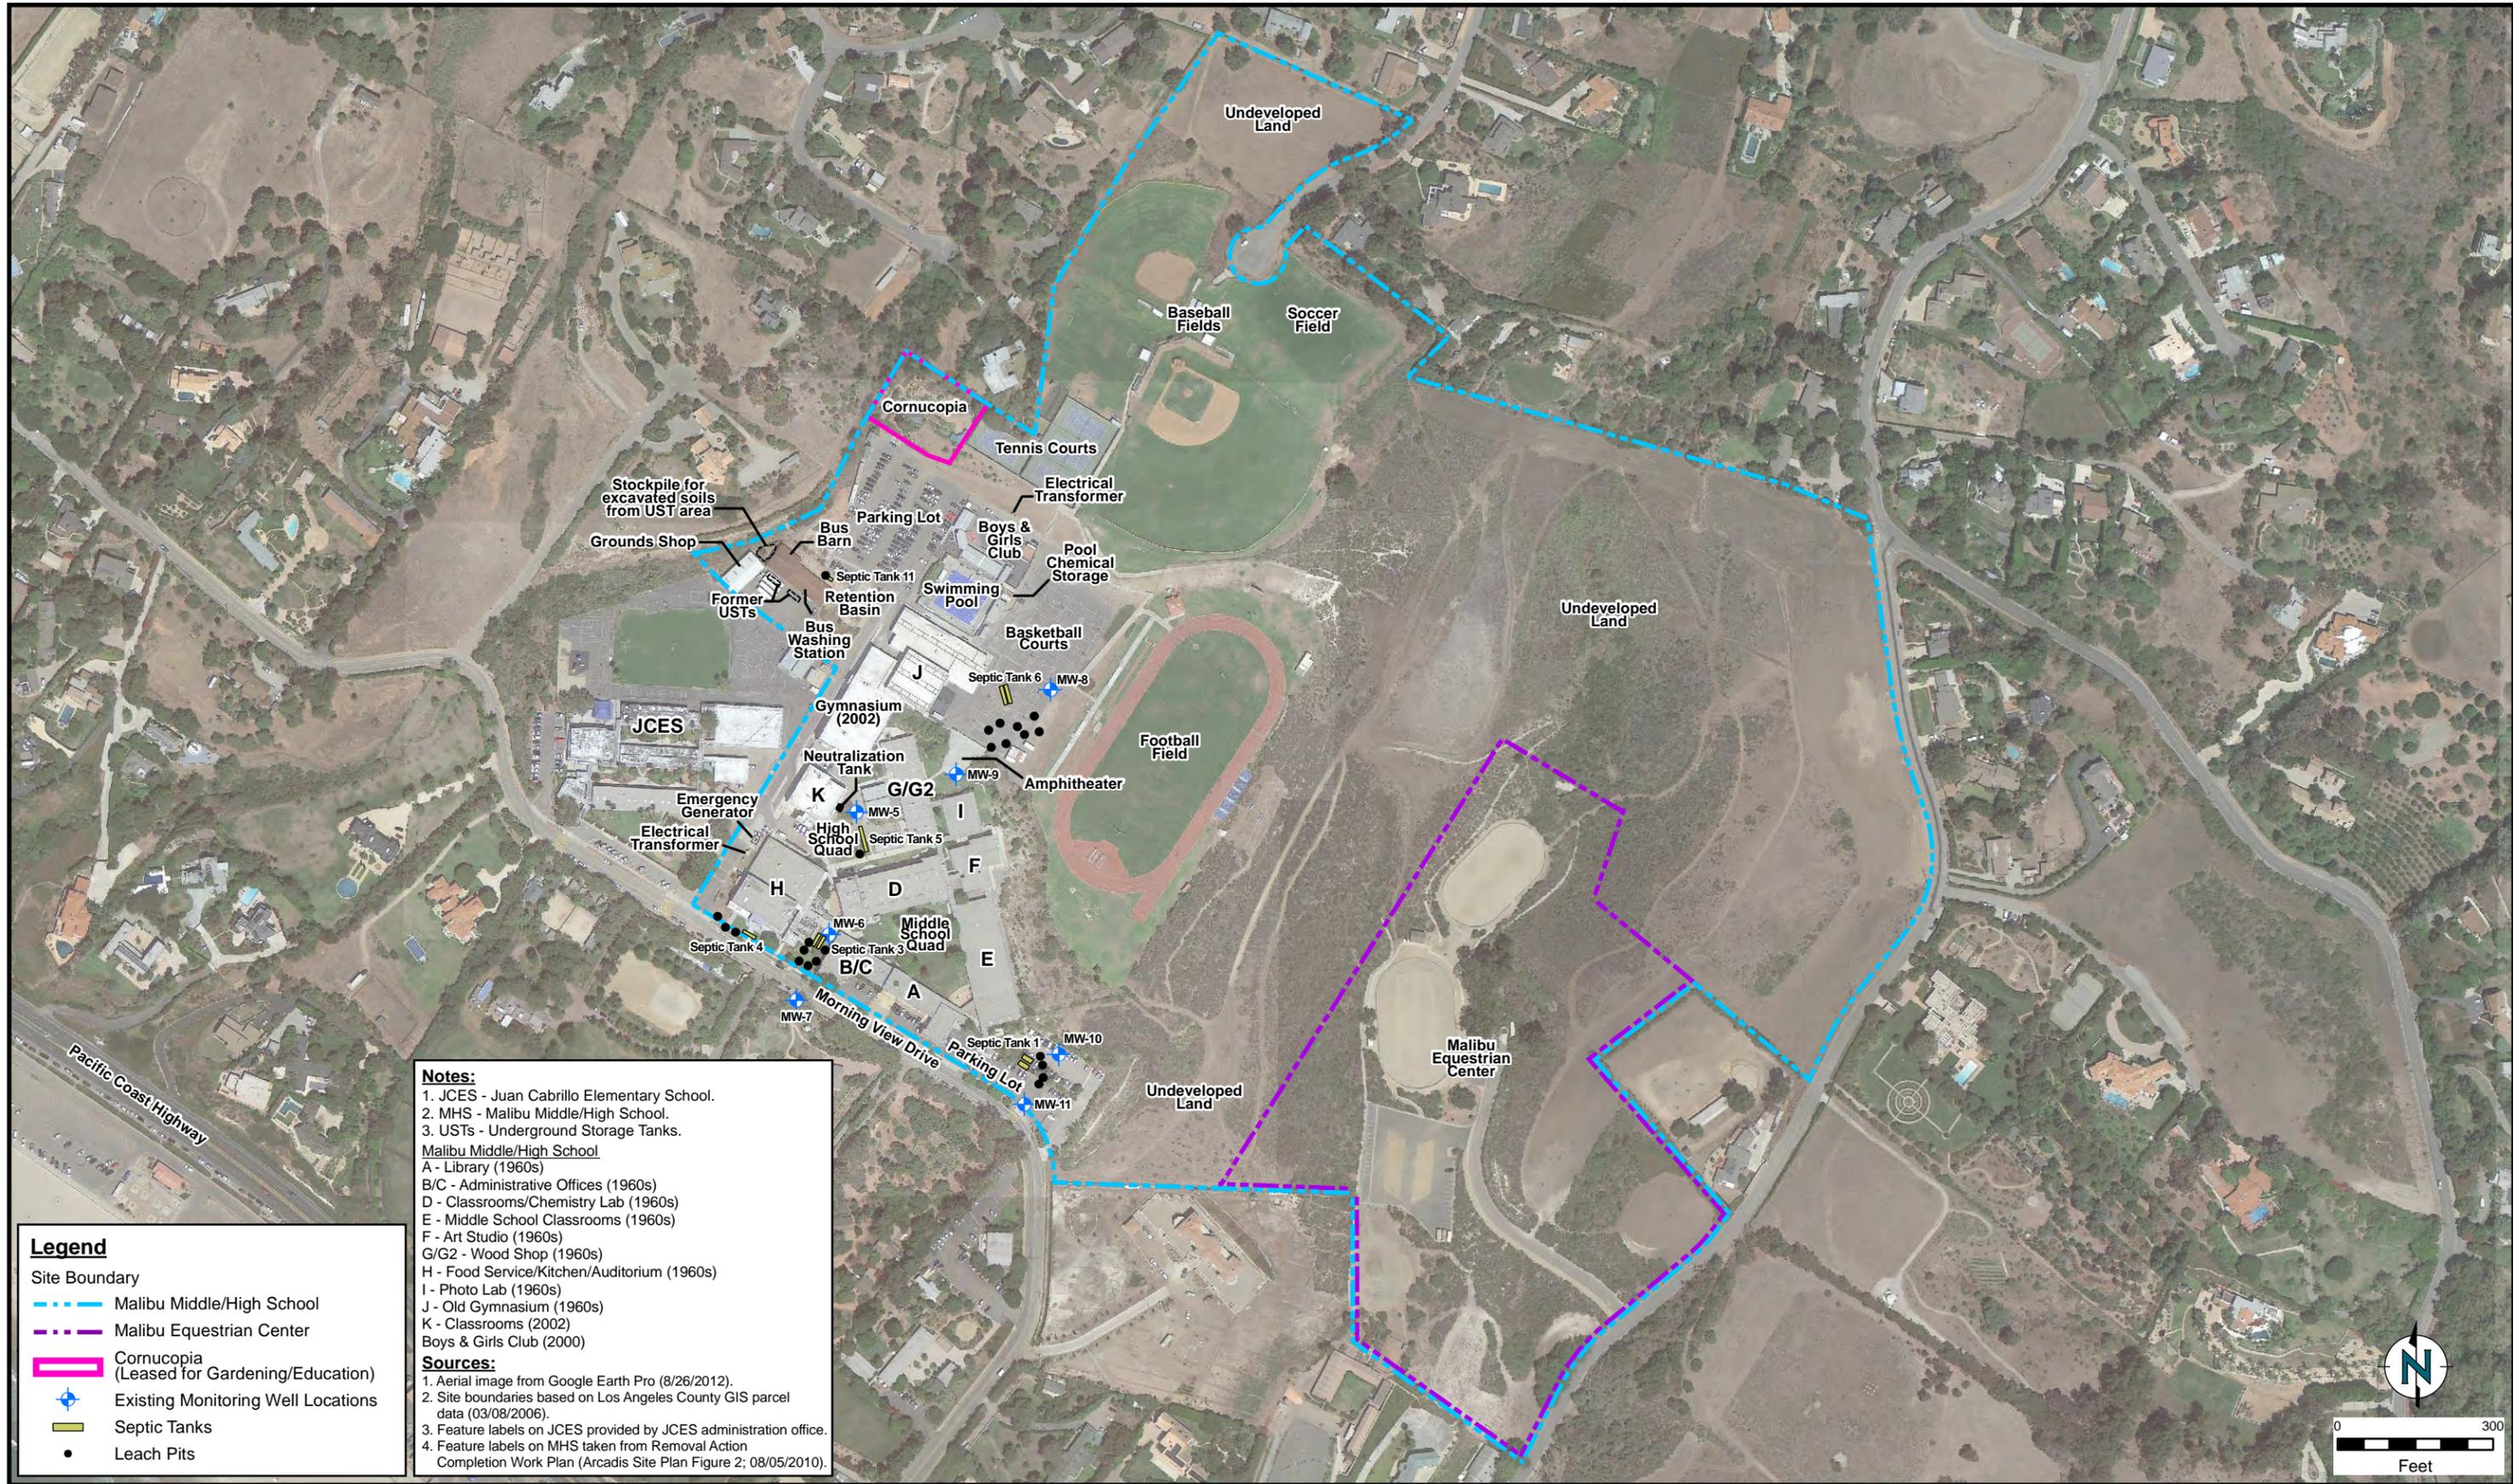
Path: Z:\01\_Projects\Malibu High School\03\_GIS\PEA Investigation\Figure 4 - Malibu Middle High School - 2014-05-22.mxd

**Legend**  
 Site Boundary  
 - - - Malibu Middle/High School  
 - - - Malibu Equestrian Center  
 Cornucopia (Leased for Gardening/Education)  
 Existing Monitoring Well Locations  
 Septic Tanks  
 Leach Pits

ENVIRON observed the septic systems and leach pits that service MHS. The septic tanks, which are listed in Table 1 and illustrated on Figure 4, are located in the southernmost parking lot (Septic Tank 1), west of the Administration Building (Septic Tank 3), south of Building H (Septic Tank 4), north of Building D (Septic Tank 5), at the basketball courts (Septic Tank 6), and north of the "Bus Barn" (Septic Tank 11). Seven monitoring wells (MW-5, 6, 7, 8, 9, 10, and 11) were observed on MHS. These monitoring wells were installed between March 28 and April 6, 2009 as part of an evaluation of and upgrade to the existing septic system under the WDR permit. The wells are monitored in compliance with the WDRs on a quarterly basis under oversight of the LARWQCB (GeoConcepts 2009).

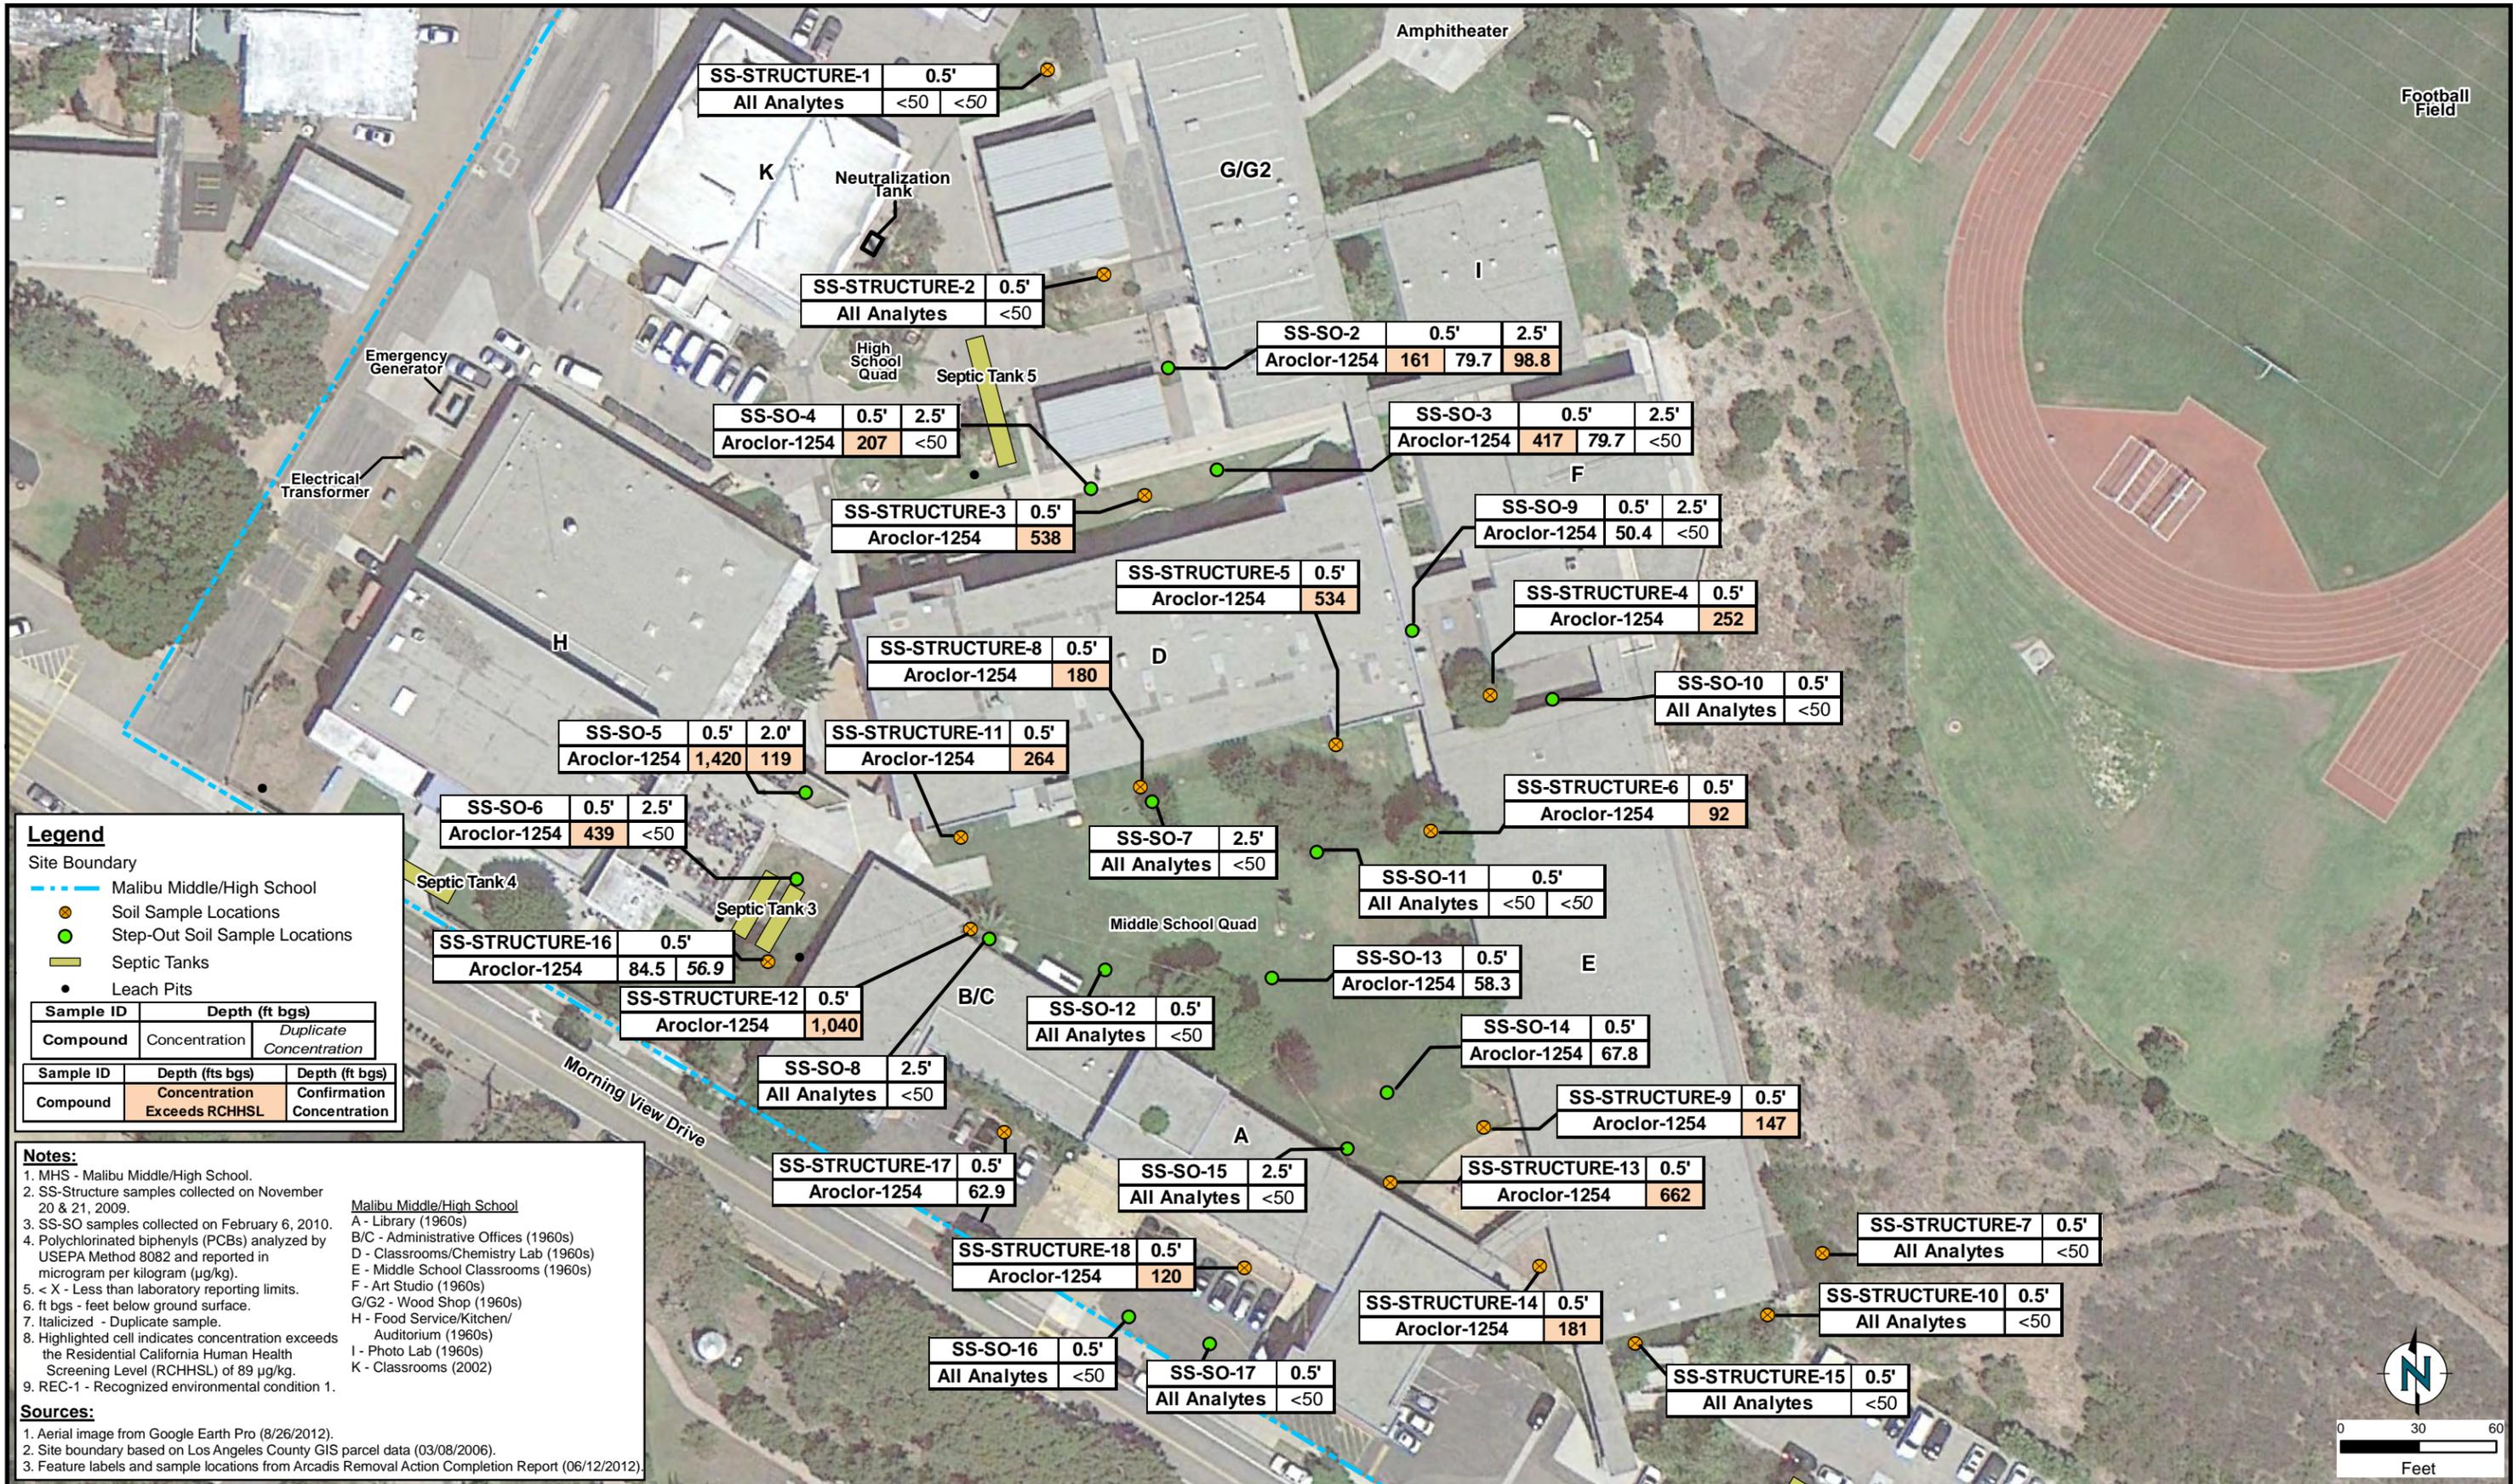
Path: Z:\01\_Projects\Malibu High School\GIS\PEA Investigation\Figure 11A - PCBs in Soil Deletion Samples on MHS - 2014-05-22.mxd

- Site Boundary
- Malibu Middle/High School
- Soil Sample Locations
- Step-Out Soil Sample Locations
- Septic Tanks
- Leach Pits

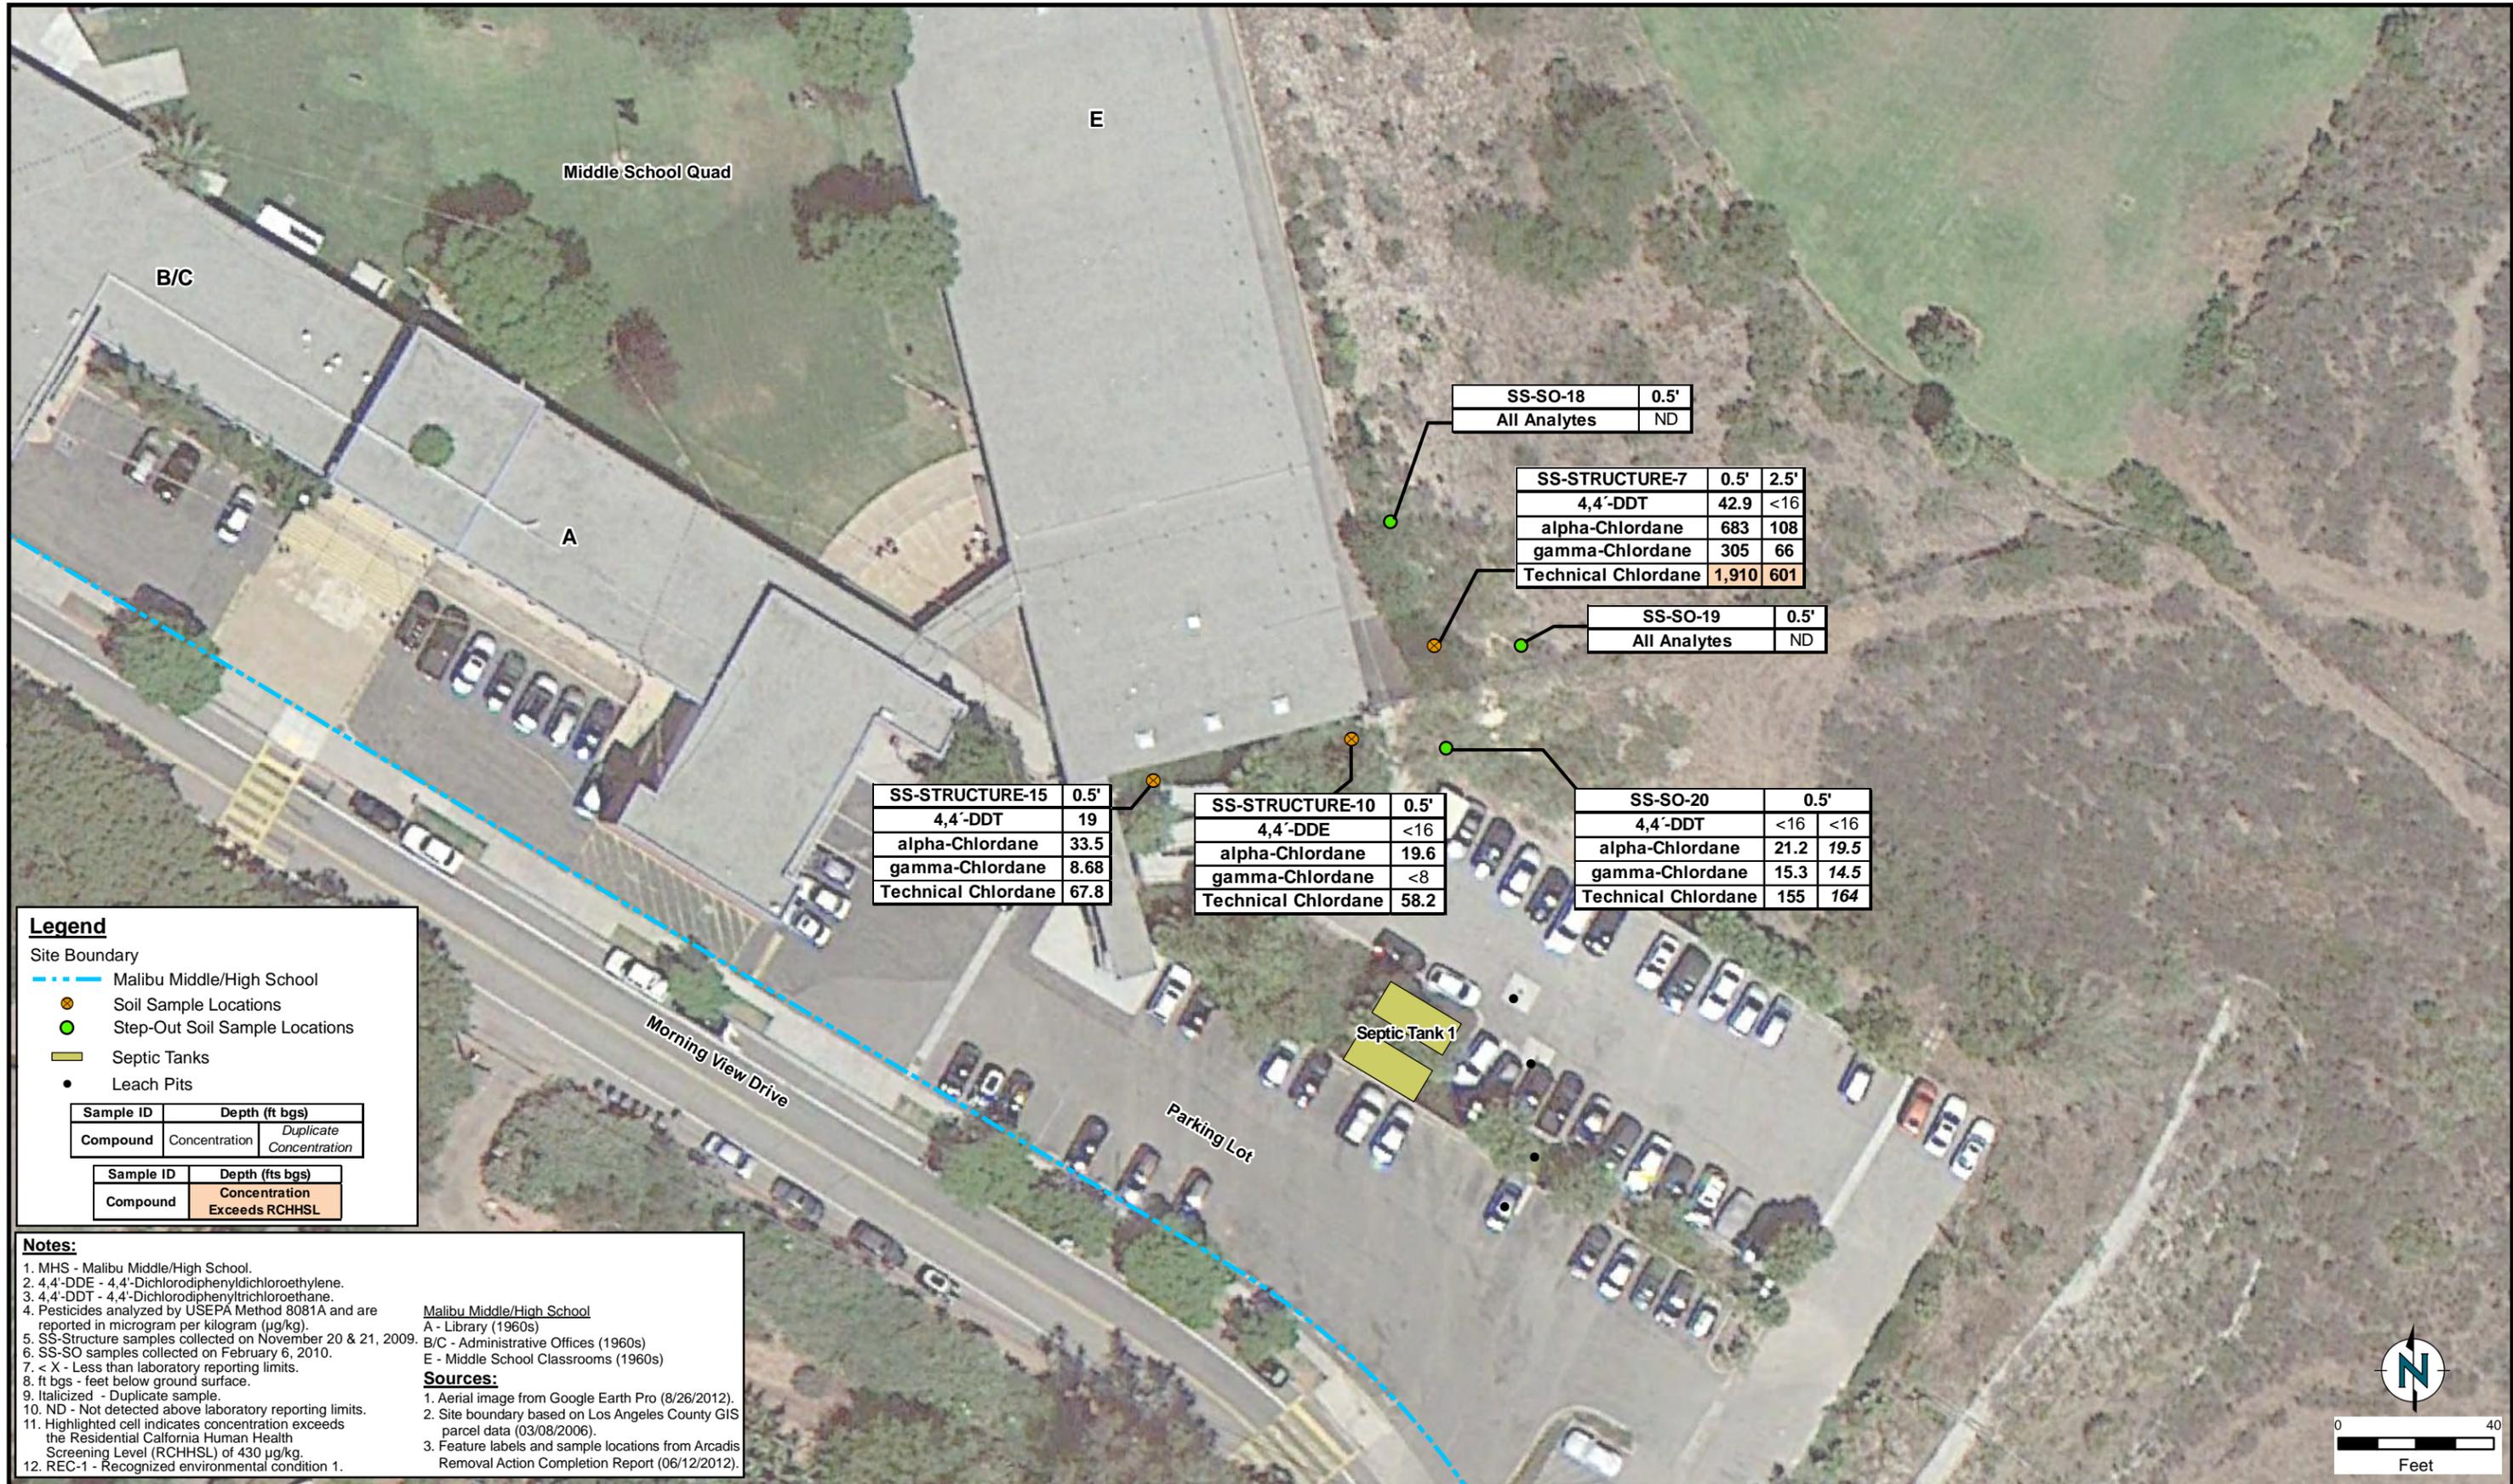
Path: Z:\01\_Projects\Malibu High School\03\_GIS\PEA Investigation\Figure 11B - Pesticides in Soil Delineation Samples on MHS - 2014-05-22.mxd

- Site Boundary
- Malibu Middle/High School
- Soil Sample Locations
- Step-Out Soil Sample Locations
- Septic Tanks
- Leach Pits

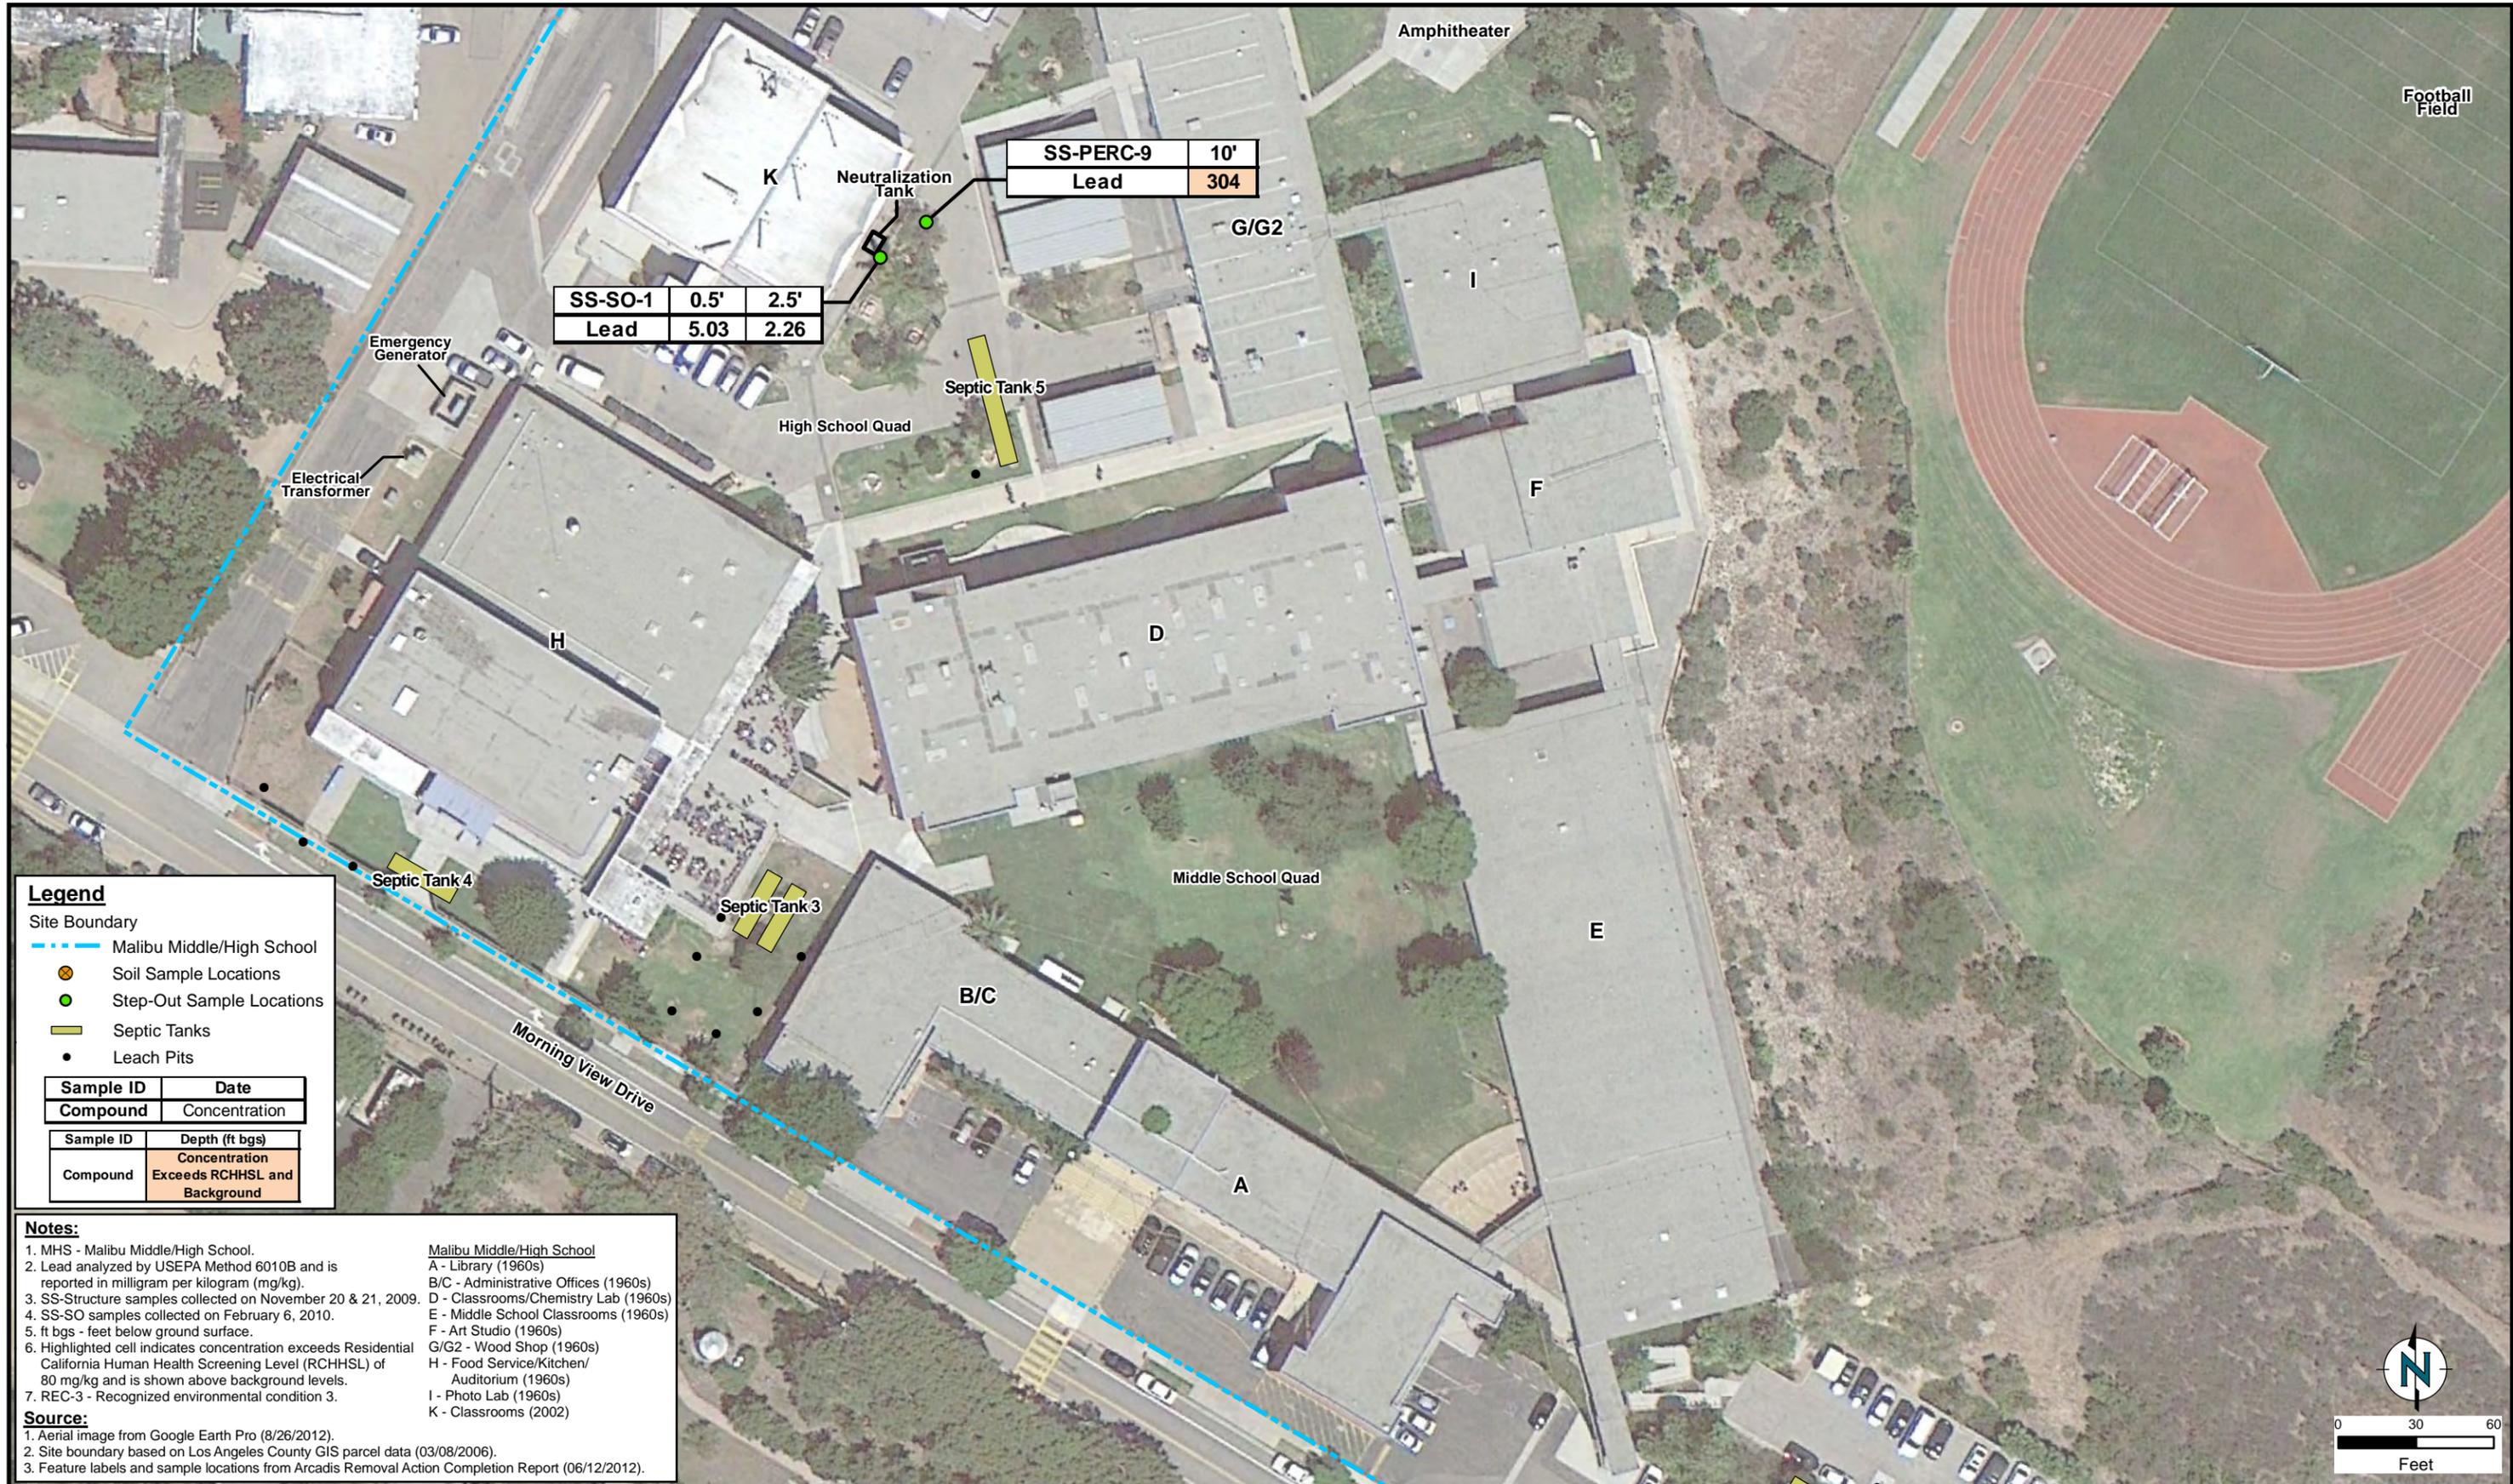
Path: Z:\01\_P\Projects\Malibu High School\03\_GIS\PEA Investigation\Figure 13B - Lead in Soil Delineation Samples on MHS - 2014-05-22.mxd

- Site Boundary
- Malibu Middle/High School
- Soil Sample Locations
- Step-Out Sample Locations
- Septic Tanks
- Leach Pits
