**D R A F T Preliminary  
Environmental Assessment  
Work Plan**  
Juan Cabrillo Elementary School and  
Malibu Middle and High Schools  
30237 and 30215 Morning View Drive  
Malibu, California

Prepared for:  
**Santa Monica-Malibu United School District**  
**Santa Monica, California**

Prepared by:  
**ENVIRON International Corporation**  
**Irvine, California**

Date:  
**May 23, 2014**

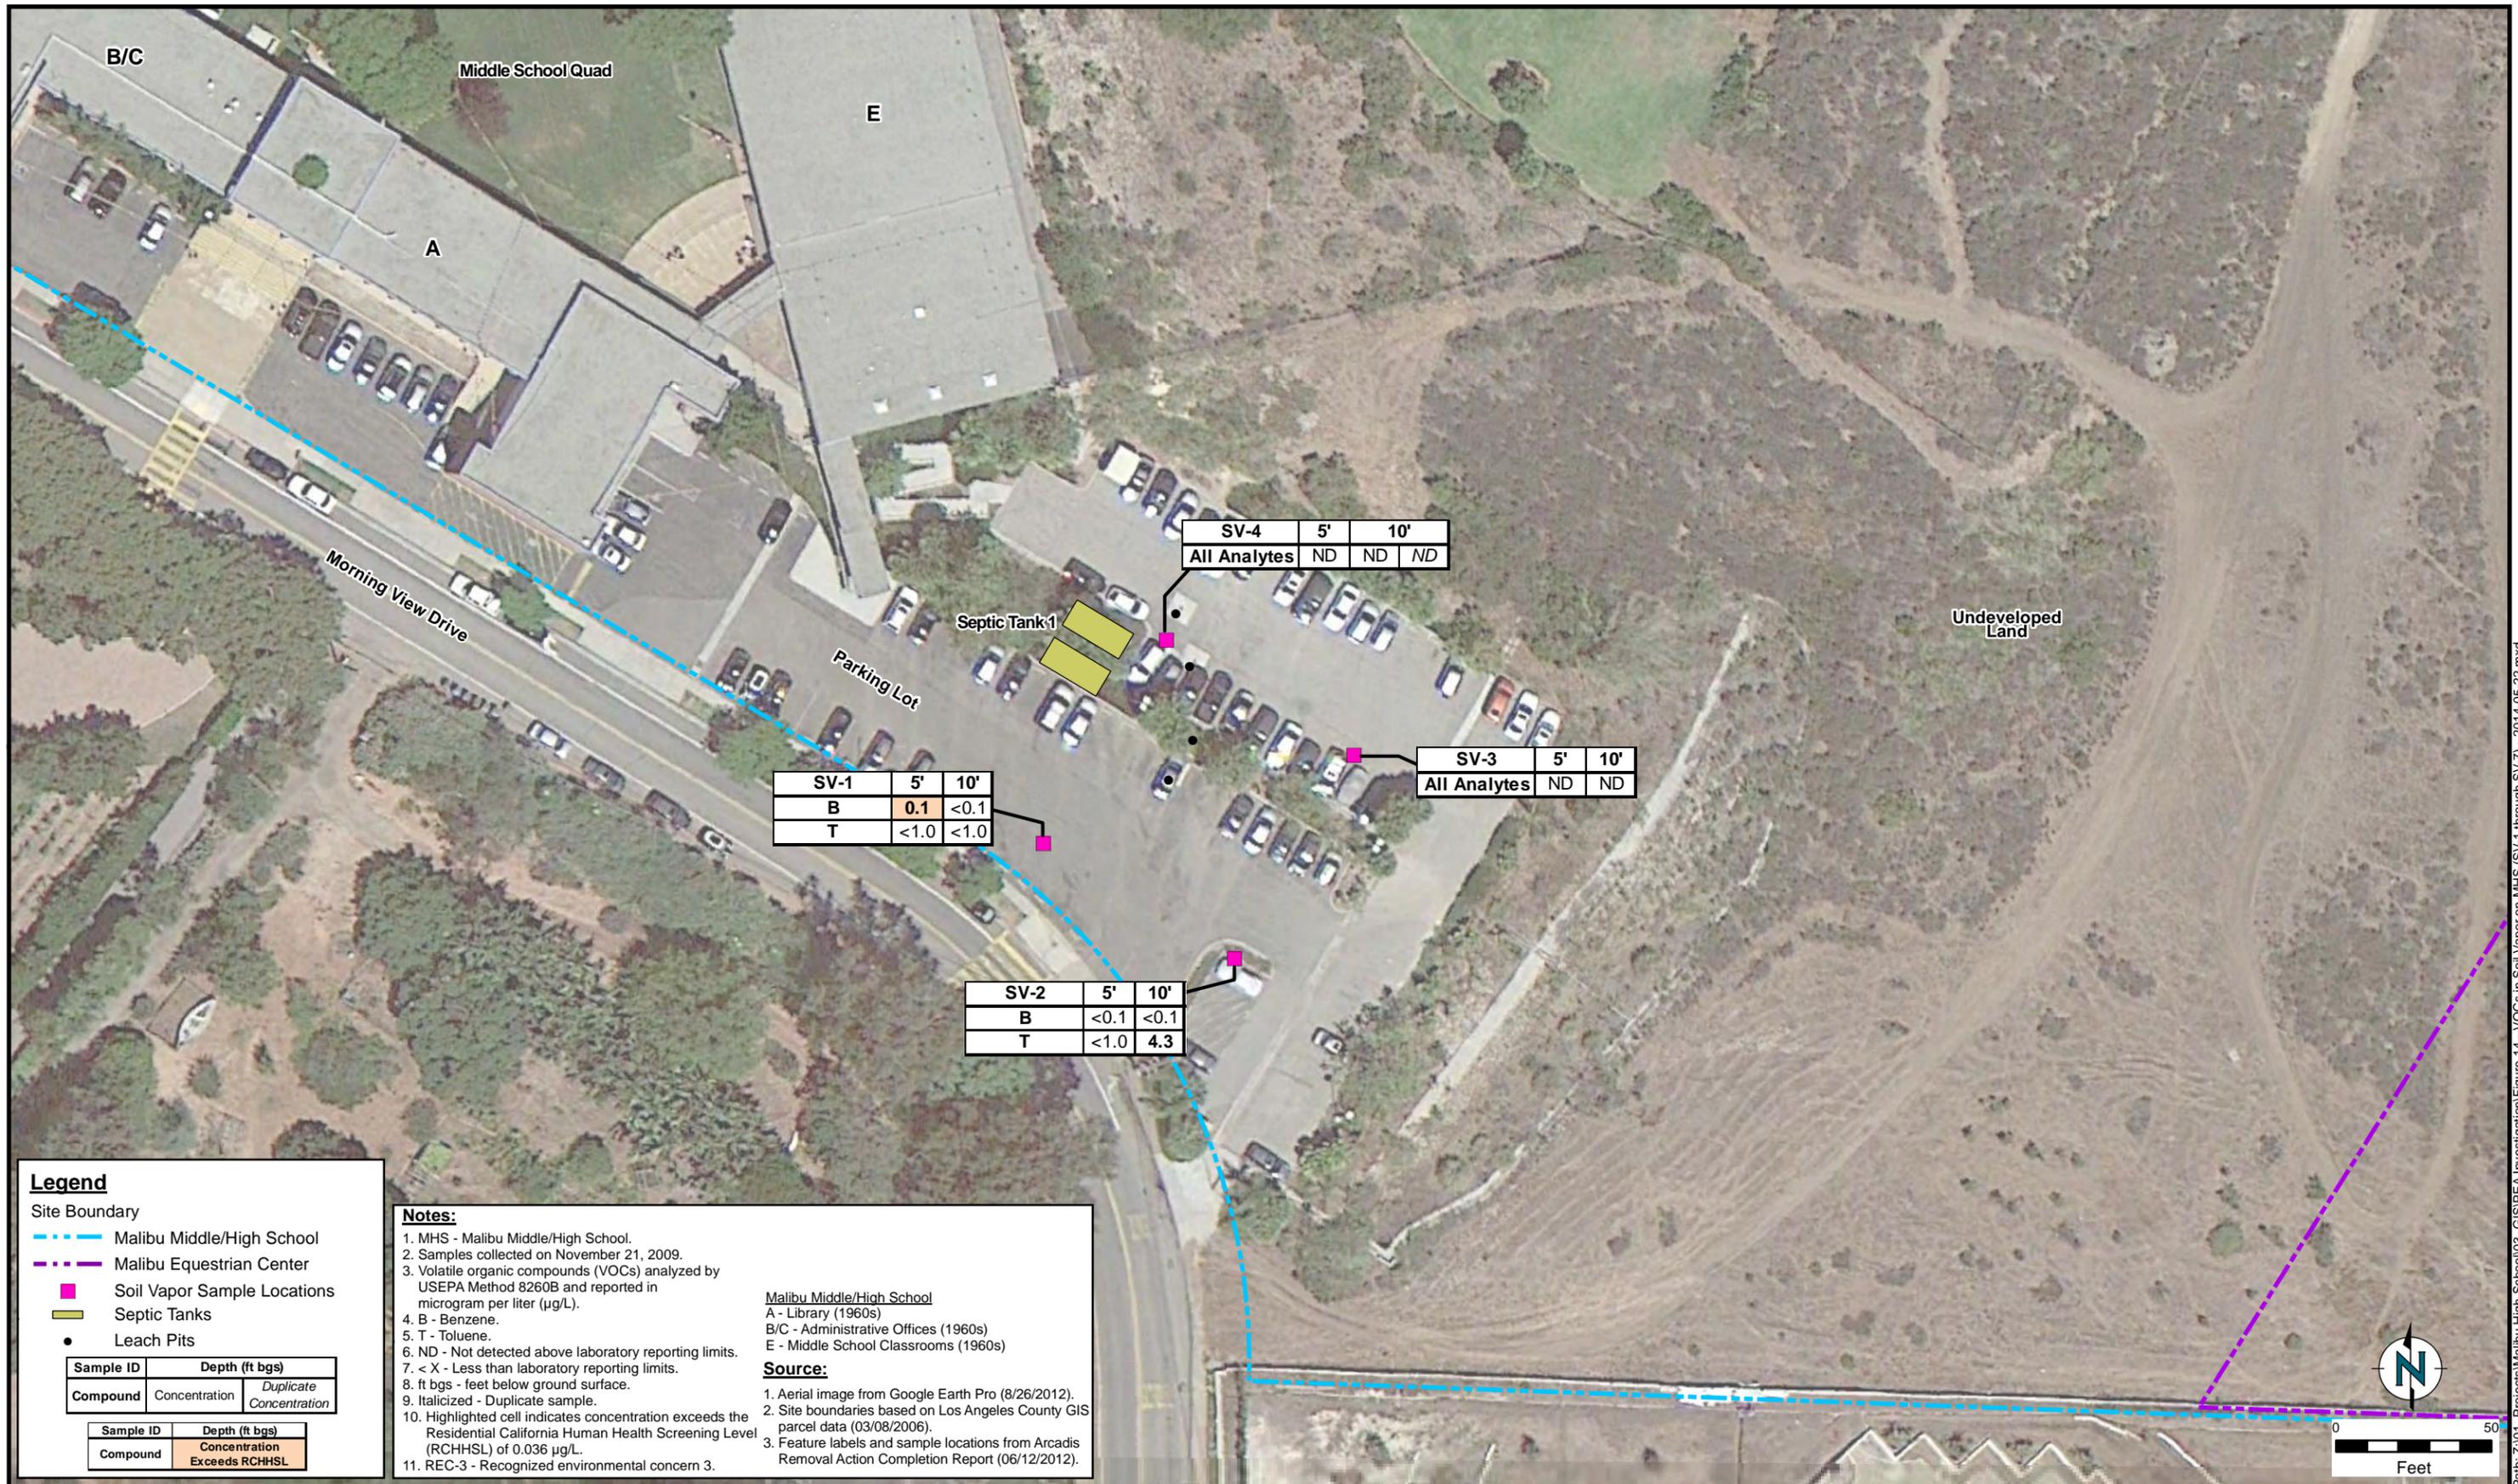
Path: Z:\01\_P\Projects\Malibu High School\03\_GIS\PEA Investigation\Figure 14 - VOCs in Soil Vapor on MHS (SV-1 through SV-7) - 2014-05-22.mxd

- Malibu Middle/High School
- Malibu Equestrian Center
- Soil Vapor Sample Locations
- Septic Tanks
- Leach Pits

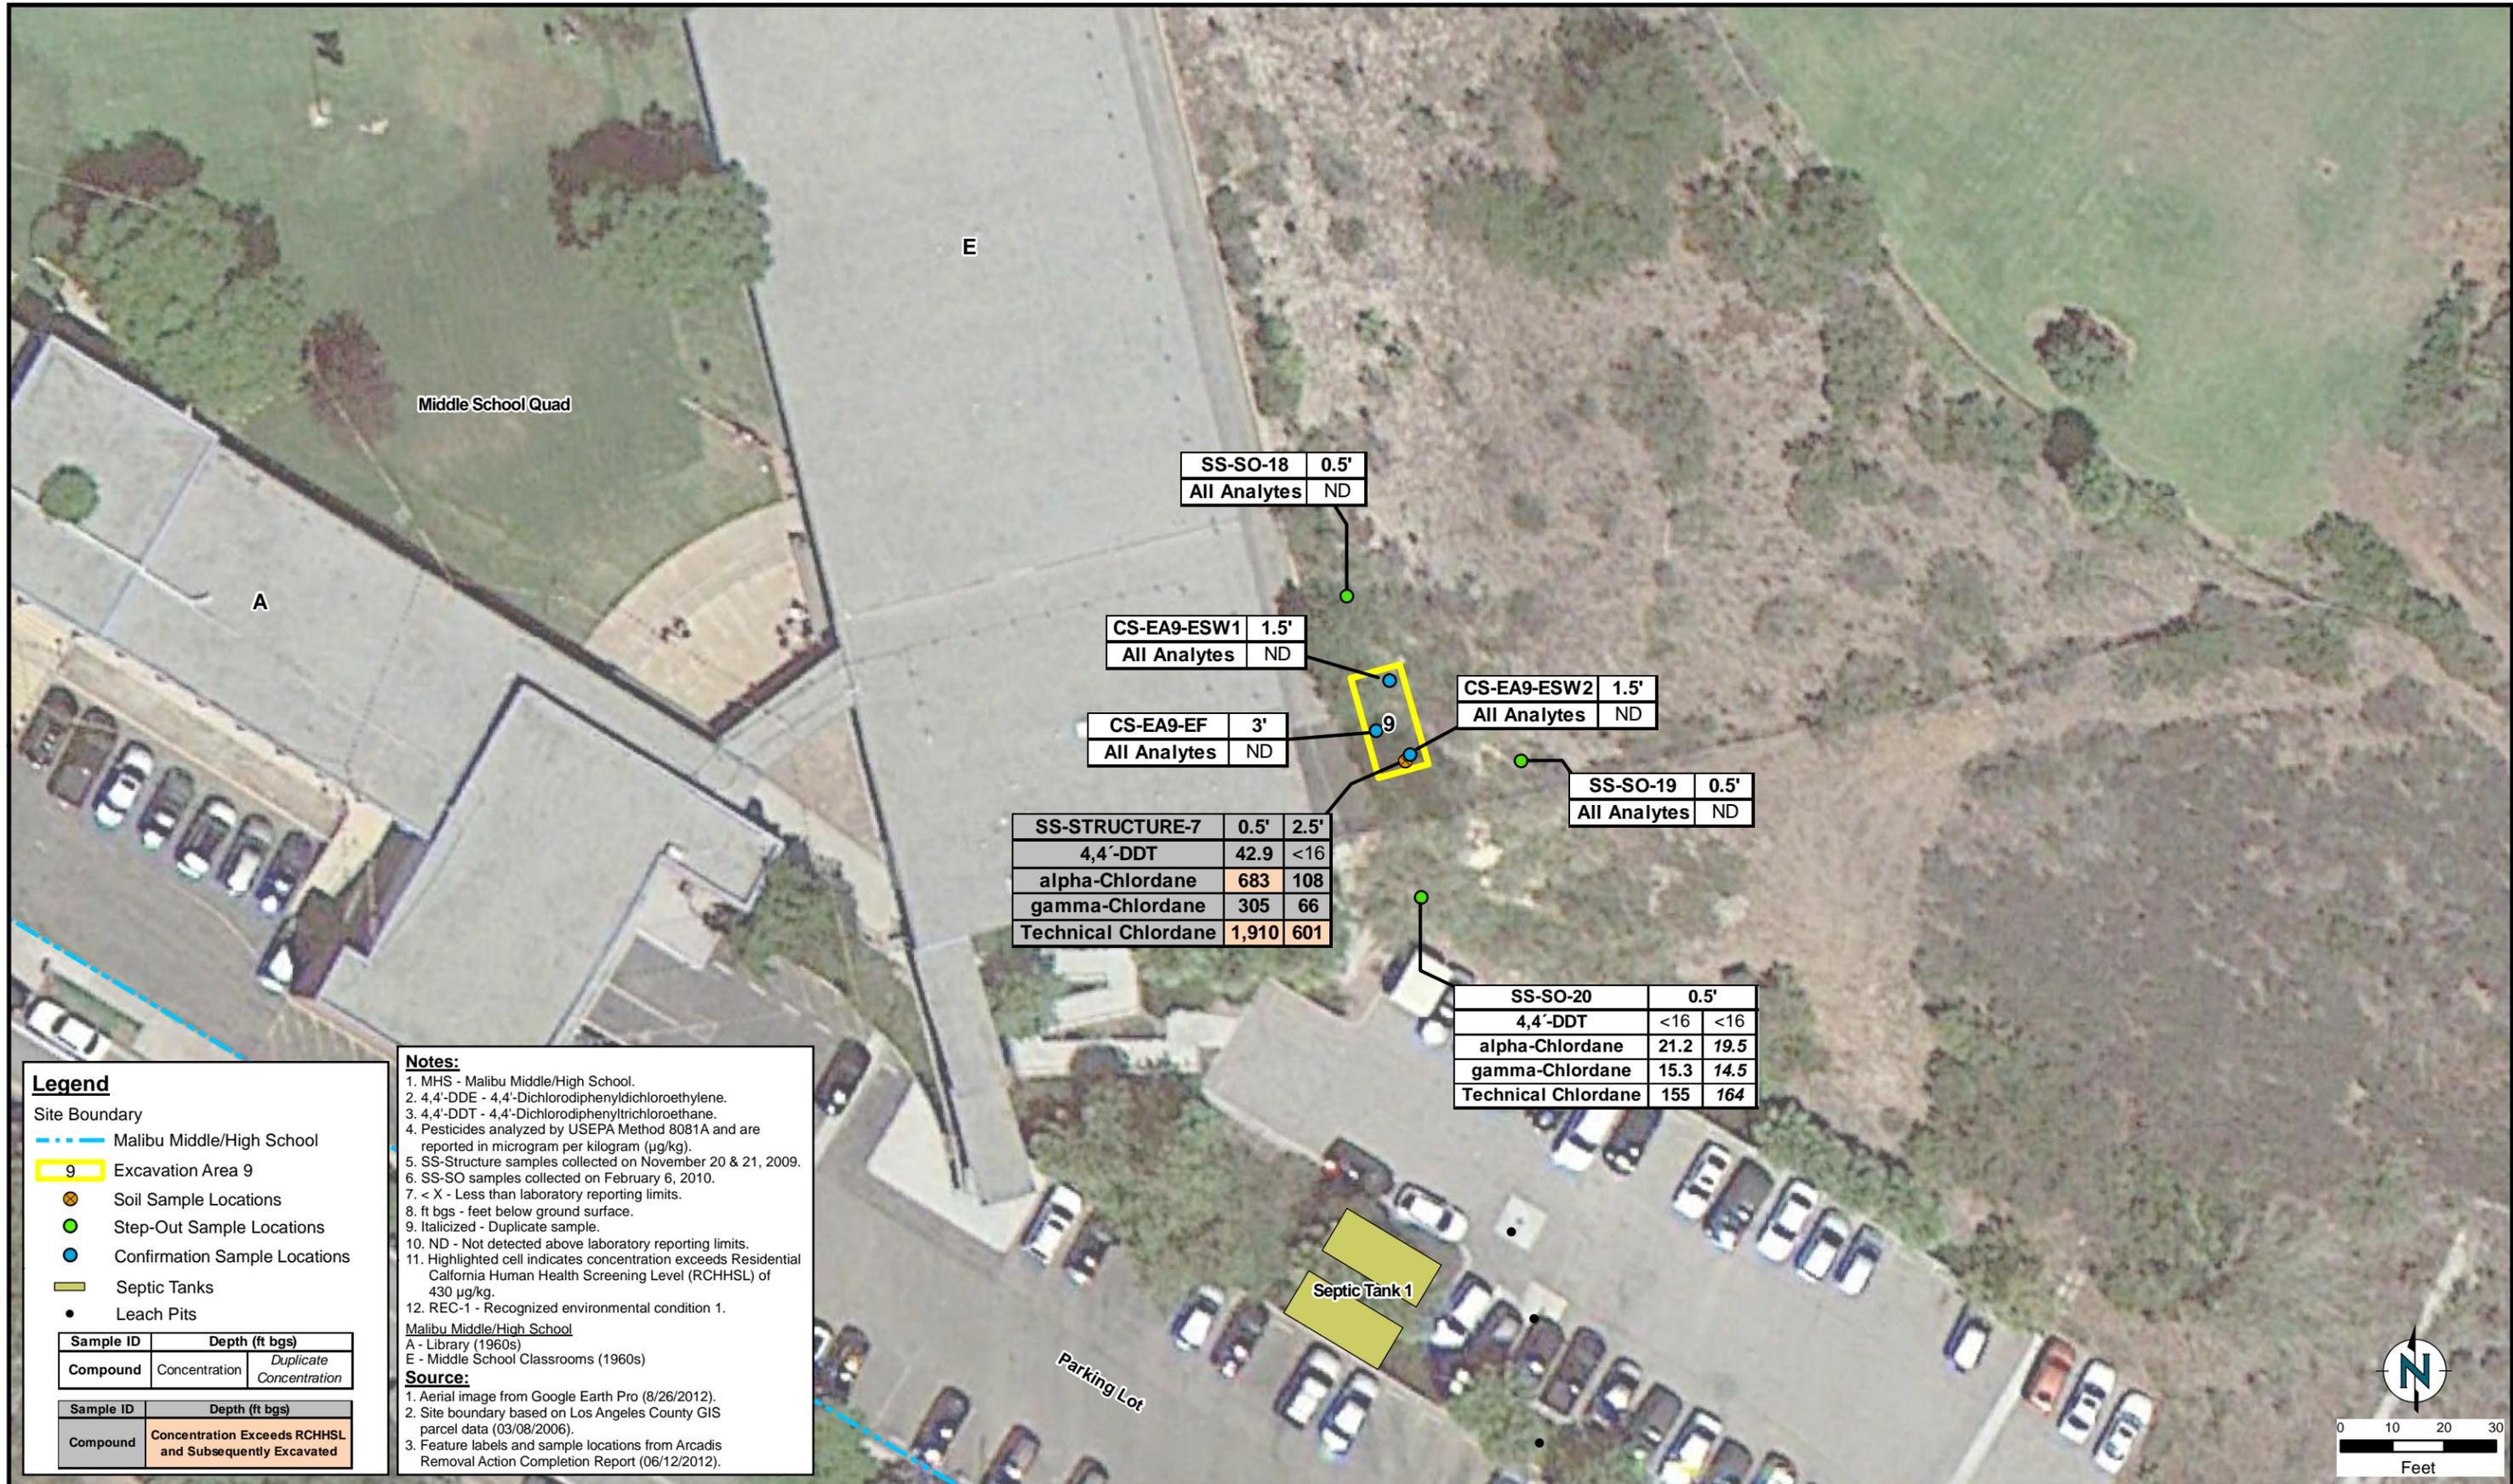
- Site Boundary
- Malibu Middle/High School
- Excavation Area 9
- Soil Sample Locations
- Step-Out Sample Locations
- Confirmation Sample Locations
- Septic Tanks
- Leach Pits

In August 2010, Arcadis prepared a Removal Action Workplan, which was implemented between July and August of 2011 to excavate, remove, and dispose of impacted soil from nine impacted areas (Areas 1 through 9); Area 9, illustrated on Figure 15A, was identified as

Area 9 was excavated to a total depth of approximately 3 feet bgs. Confirmation samples collected from the bottom and sidewalls of the excavation indicated that pesticides were not detected above their respective laboratory reporting limits (See Figure 15A).

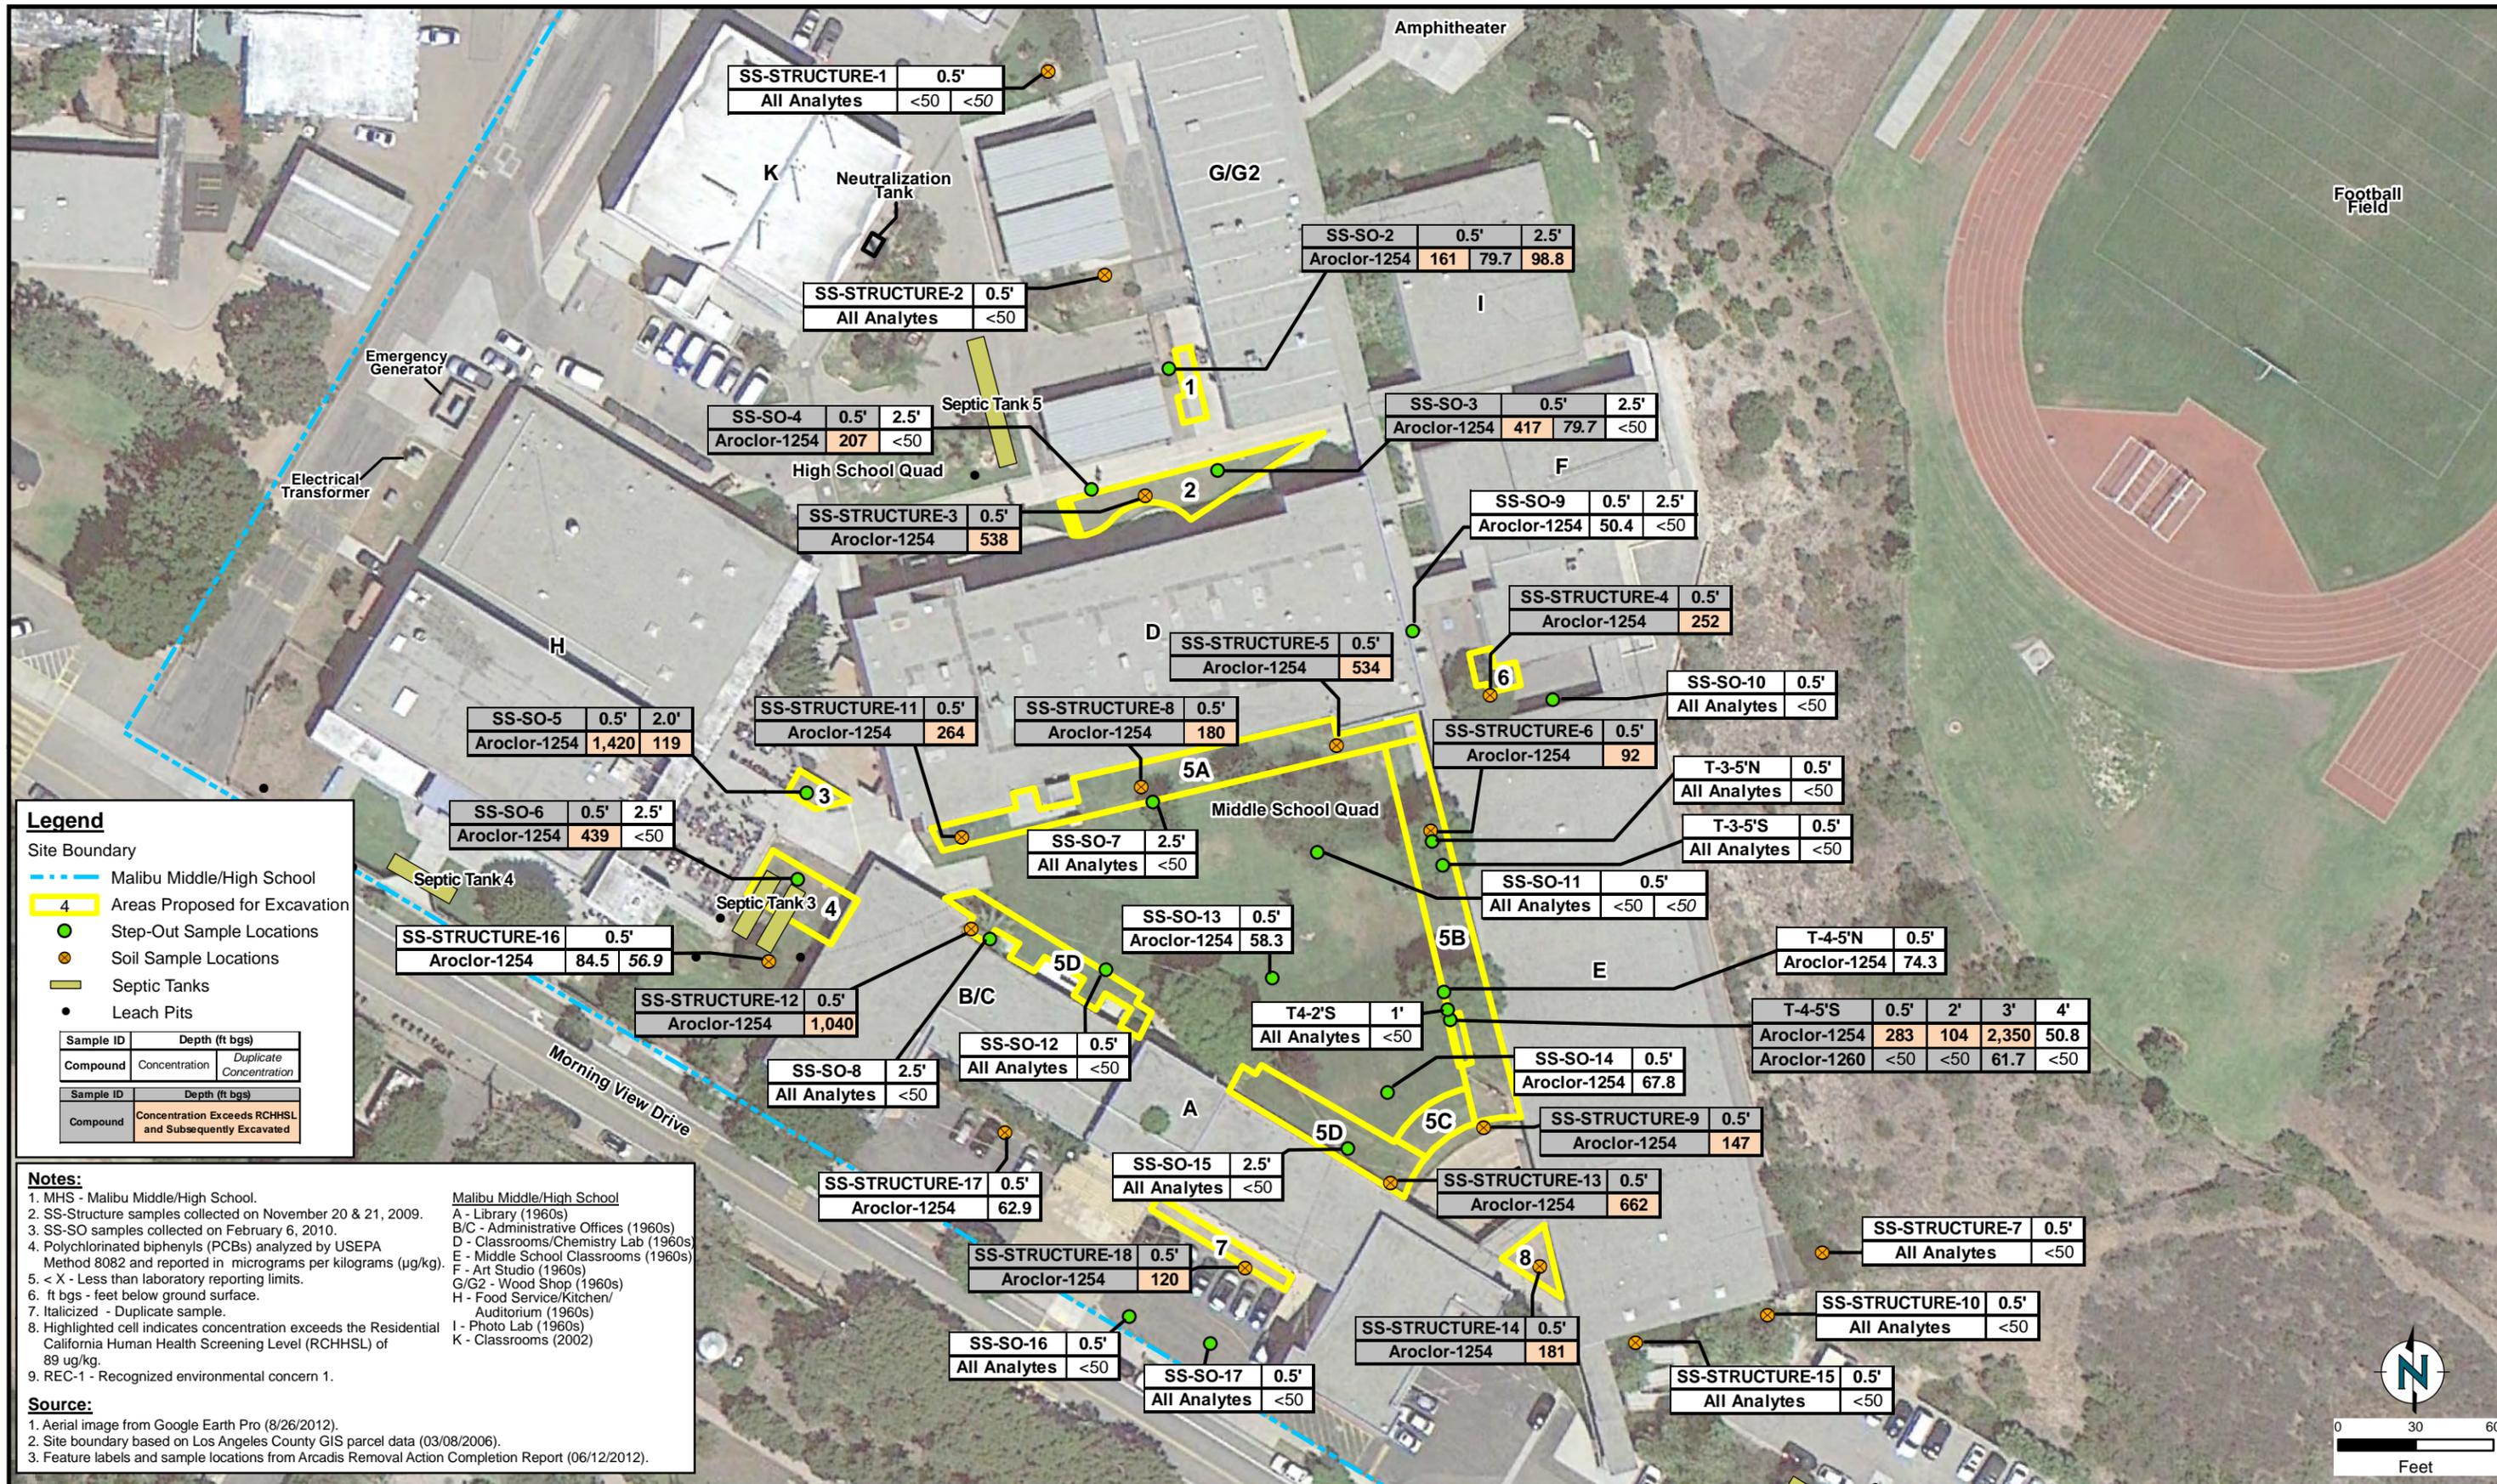
Path: Z:\01\_Projects\Malibu High School\GIS\PEA Investigation\Figure 15B - Extent of Excavated Soil for PCBs on MHS - 2014-05-22.mxd

Site Boundary  
 - - - - - Malibu Middle/High School  
 4 Areas Proposed for Excavation  
 ● Step-Out Sample Locations  
 ● Soil Sample Locations  
 ■ Septic Tanks  
 ● Leach Pits

pesticide-impacted soil and the remaining eight areas (Areas 1-8) illustrated on Figure 15B were identified as PCB-impacted soil. In total, approximately 1,179 cubic yards (yds<sup>3</sup>) of pesticide and PCB-impacted soil was excavated (Figure 15C), subsequently characterized as non-hazardous, and disposed of at the Chiquita Canyon Landfill in Castaic, California. Details of the excavation conducted in each of the areas are discussed below:

PCB-impacted soil identified in Areas 1 through 8 was excavated vertically and laterally until confirmation soil samples were below the respective PCGs of 89 µg/kg. In total, approximately 1,179 cubic yards (yds<sup>3</sup>) was estimated to have been removed, characterized as non-hazardous, and disposed of at Chiquita Canyon Landfill in Castaic, California.

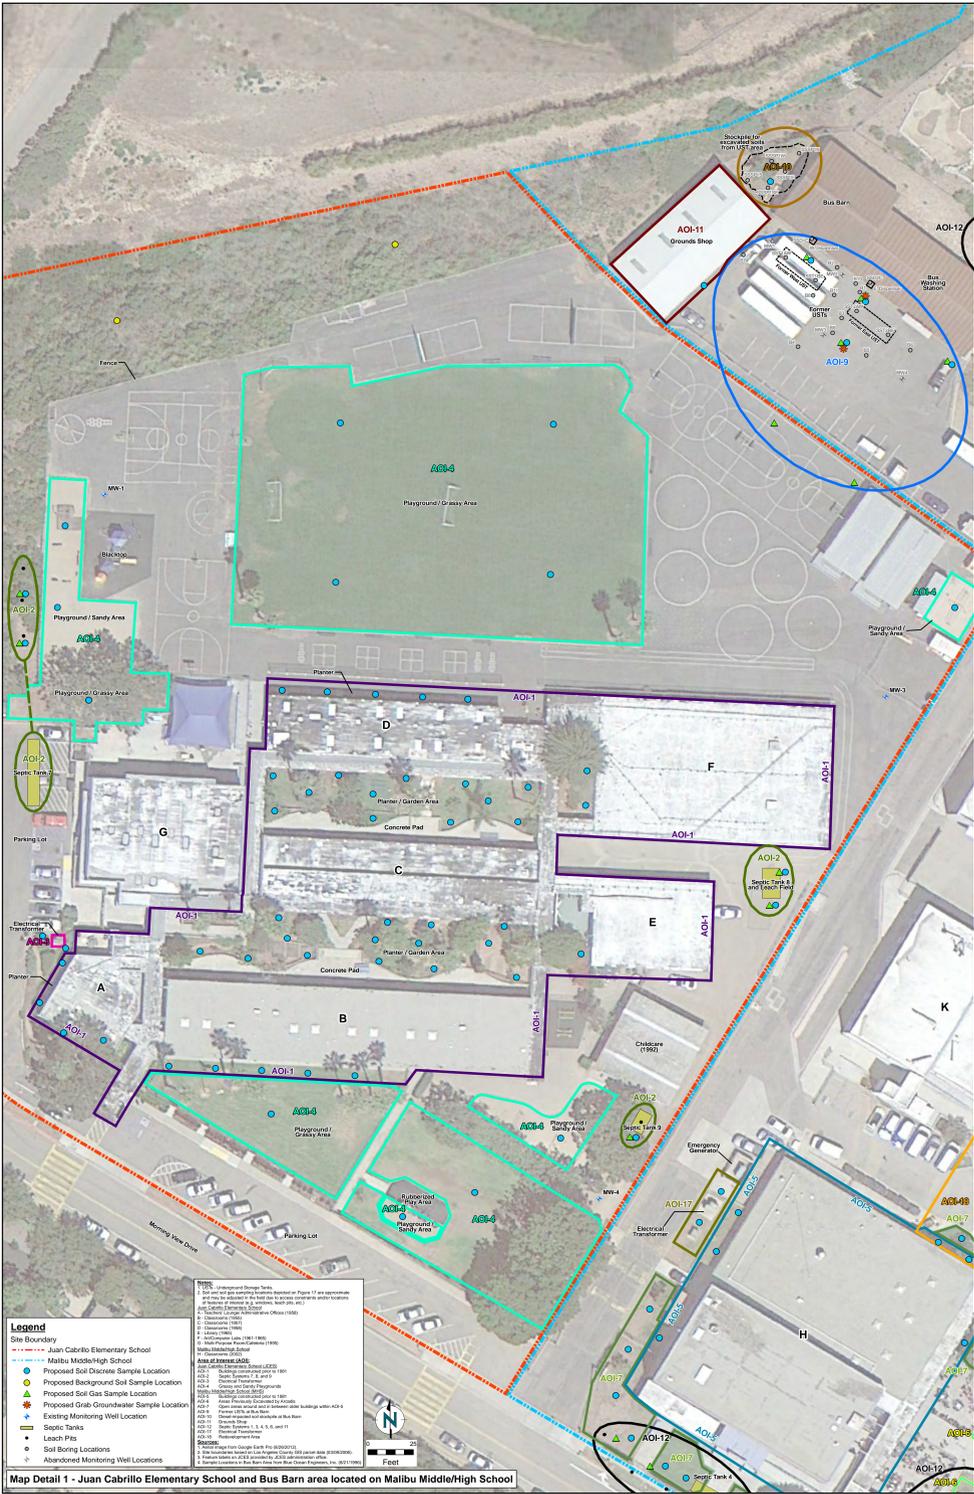
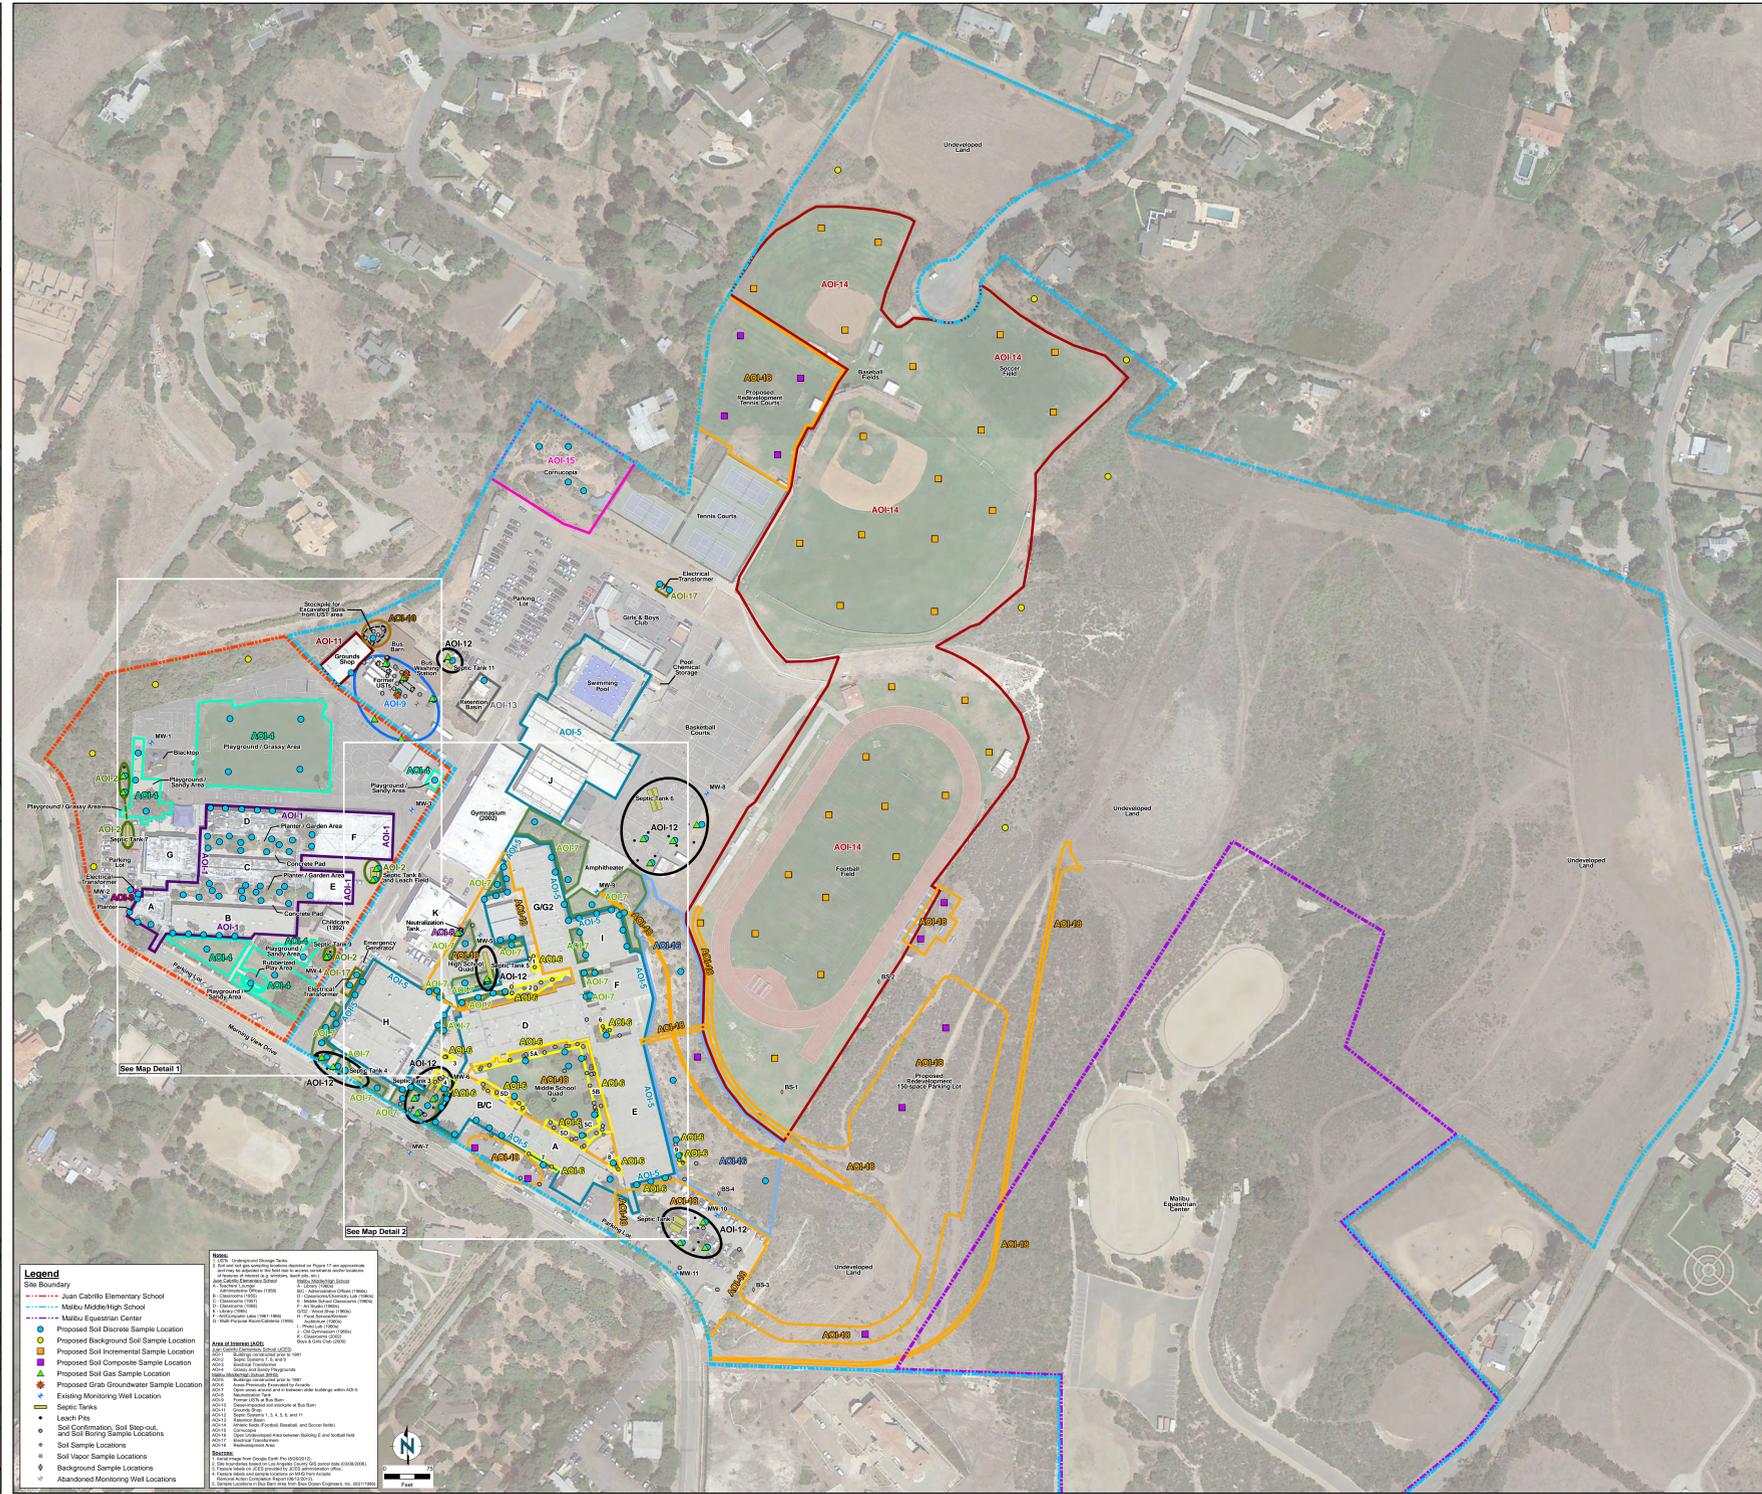
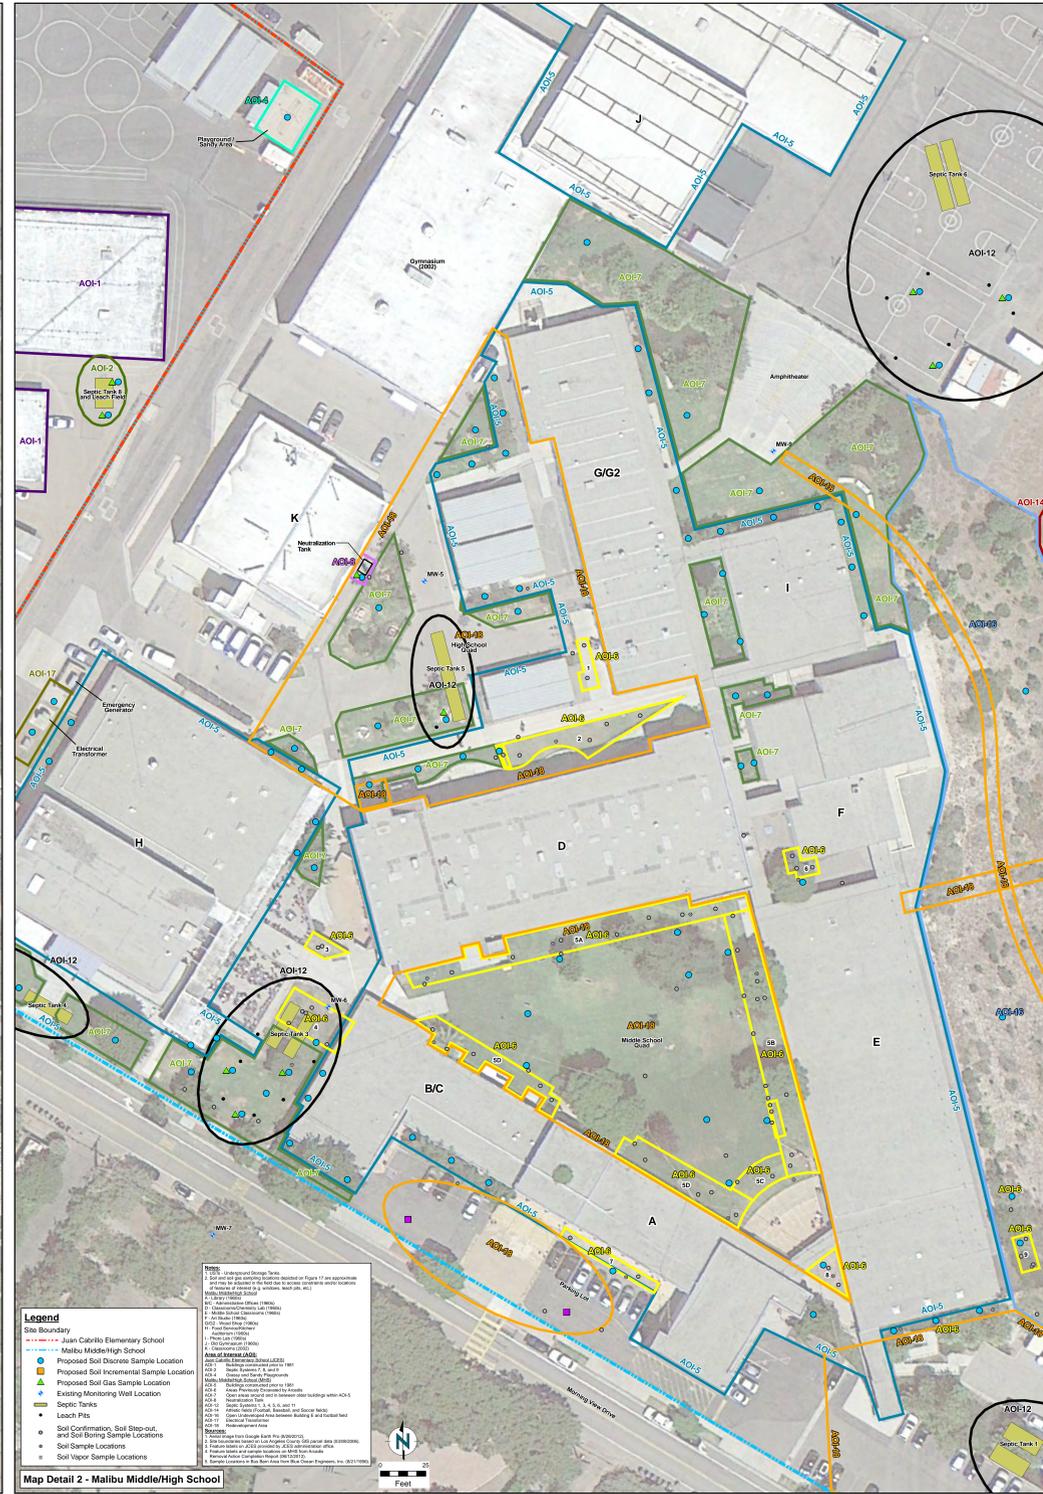
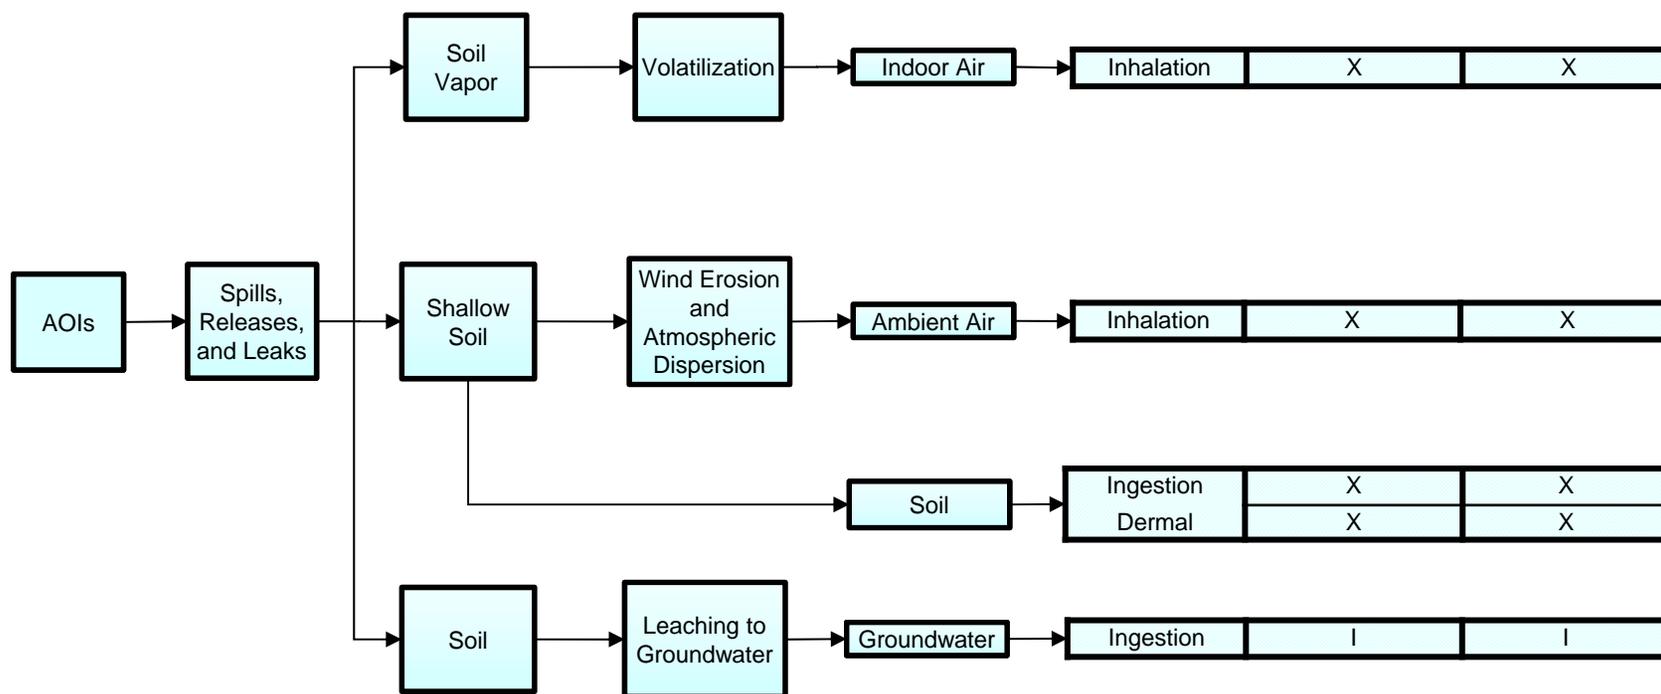
Primary Source	Release Mechanism	Secondary Source	Release Mechanism	Exposure Media	Exposure Pathway	Current Receptor	Hypothetical Future Receptor
						Staff/Student	Resident

Notes:  
 X = Potentially complete exposure pathway that will be evaluated  
 I = Incomplete exposure pathway that will not be evaluated  
 AOIs – Areas of Interest  
 HHSRE – Human Health Screening Risk Evaluation
