**Department of Toxic Substances Control
Site Visit Report**

Site/Project Name:	Quemetco
PCA/SiteCode/WR#:	300225-48 / 22120
Purpose of Visit:	Field Oversight of Implementation of 2013 Emergency Interim Measures WP

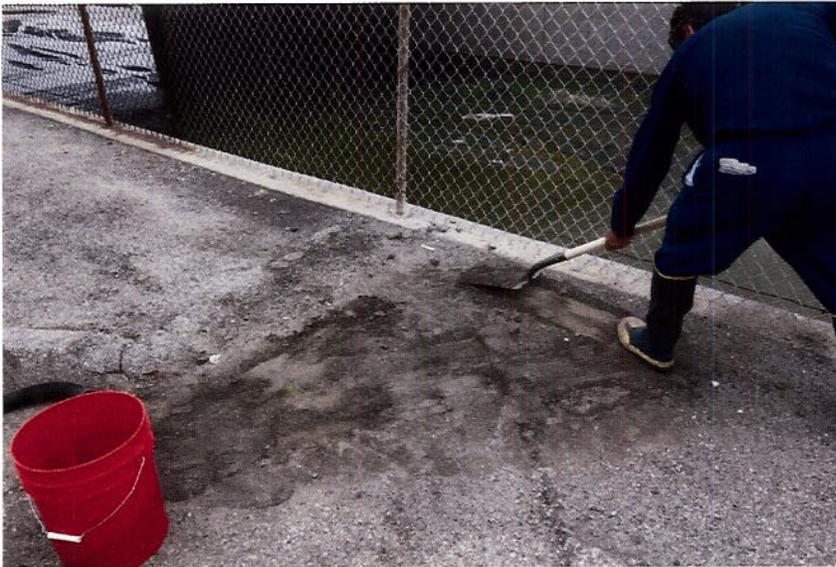
Photo 1.

Comments:			
<ul style="list-style-type: none"> • <i>Issues observed during event:</i> • In general, WSP followed the sampling and removal procedures listed in the EIM WP, and also our recommendations. However, scope will need substantial expansion to better satisfy the main goal of the EIM; which is to remove all hazardous waste from the LAFCC access area. • Recommend area be expanded to include surrounding sidewalks, surface streets, tree planters, and off-site flat roofs for hazardous lead. This includes storm drains and San Jose Creek. Screening and sampling of dust, sediment, soil may require a combination of XRF and portable min-vacuums (e.g., MicroVac, Mighty Mite) with cartridges or vacuum bags for collecting representative samples. 			
Attachment(s):			
<ul style="list-style-type: none"> • 8 photos (Quemetco EIM03, EIM05, EIM08, EIM10, EIM11, EIM16, EIM19, and EIM20). • Photo Log: <ol style="list-style-type: none"> 1. Quemetco removing soil containing lead hazardous waste. 2. WSP analyzing 'cleaned' area with XRF 3. WSP collecting soil samples from FCC-1 area. 4. Vacuumed and shoveled area still showing residual and embedded material 5. Quemetco vacuuming FCC-1 area. 6. WSP analyzing tree planter at S7A-7 location with XRF. 7. WSP collecting a soil sample from tree planter (at S7A-7 location). 8. WSP analyzing soil within tree planter with XRF.
