RCRA FACILITY ASSESSMENT
SOUTHERN CALIFORNIA CHEMICAL COMPANY, INC.
SANTA FE SPRINGS, CALIFORNIA

EPA I.D. No. CAD008488025

September, 1987

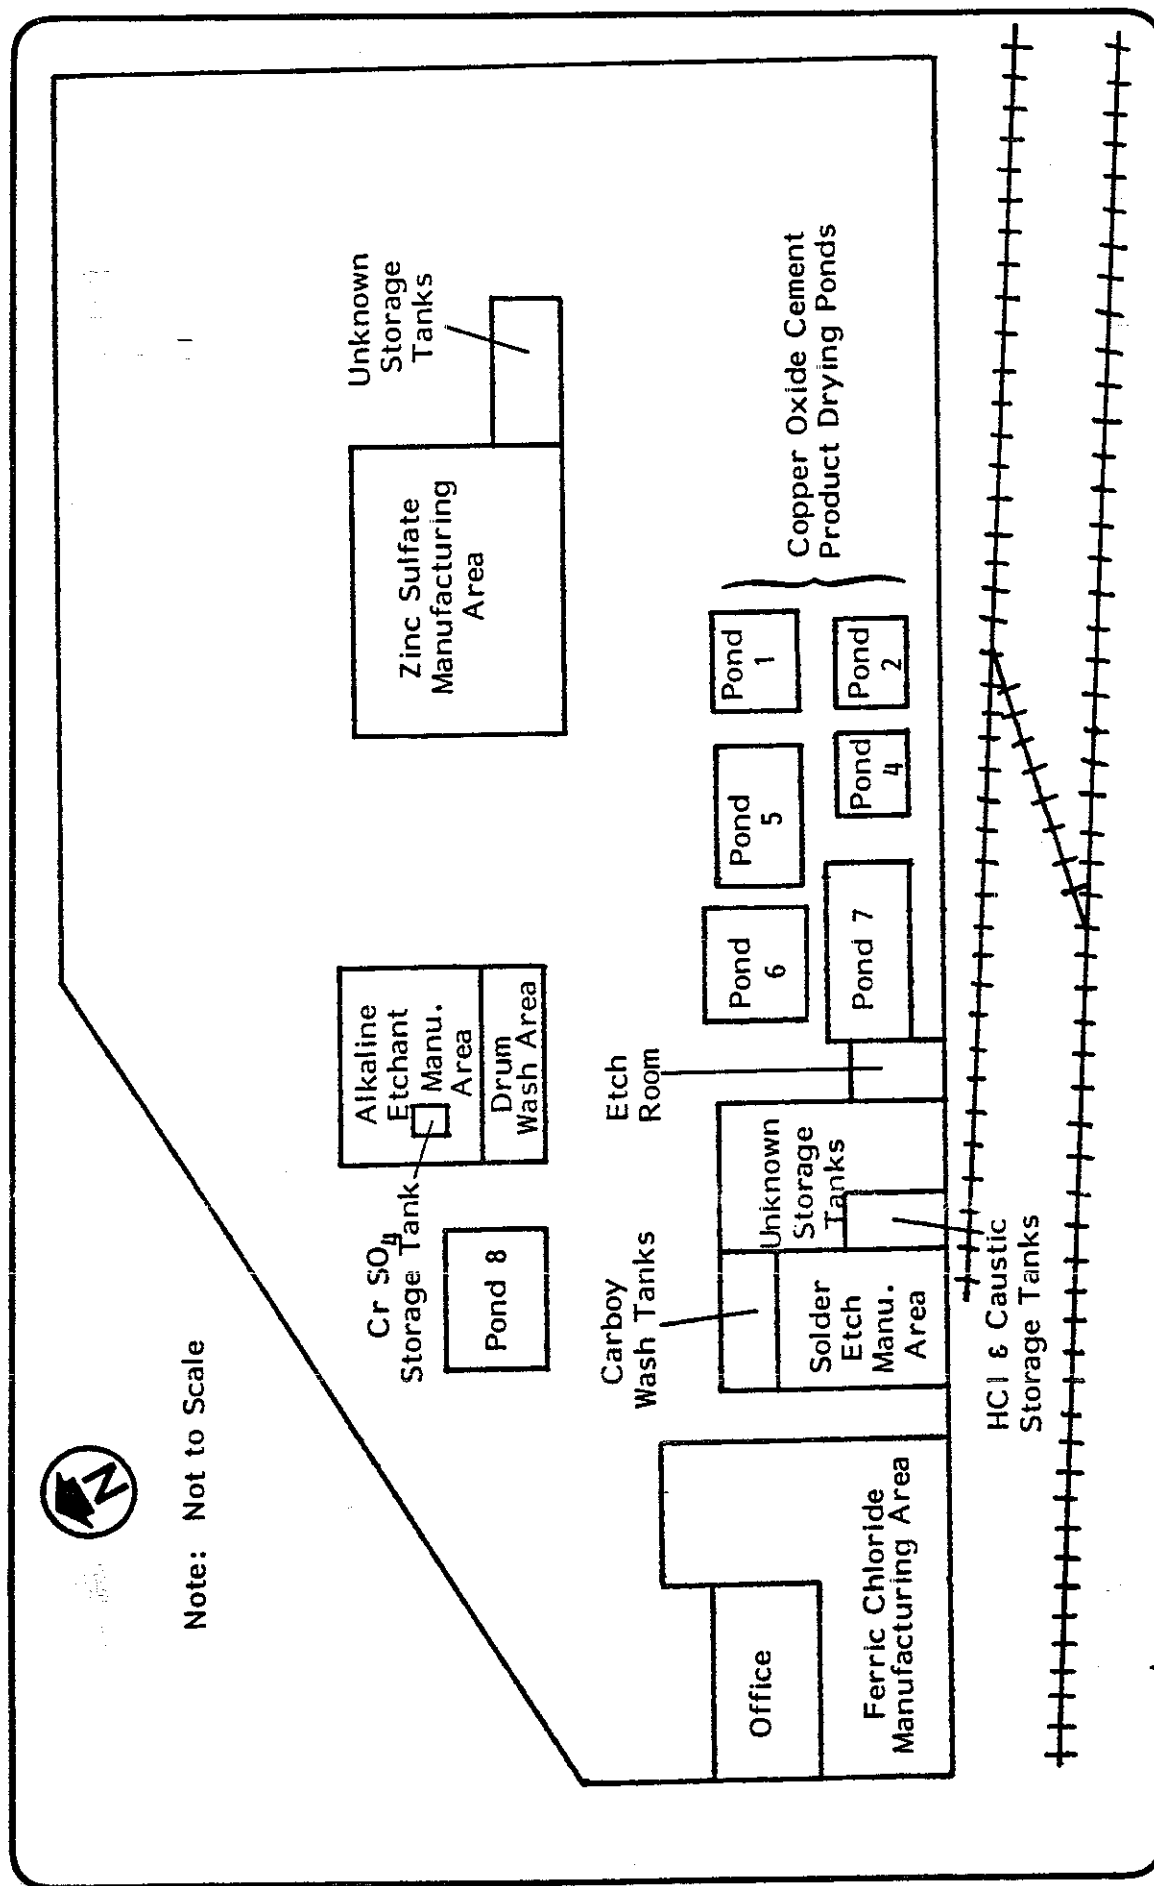
Figure 2

In 1971, facility maps (Figure 2) indicate that operations included a zinc sulfate process, ferric chloride manufacture, and alkaline and solder etchant manufacturing.(1) By 1977 (Figure 3), the operations included the same processes as in 1971 (although in different areas), and the addition of a copper leaching area and acid and caustic etchant processes. In 1978, the facility

CONFIGURATION OF SOUTHERN CALIFORNIA CHEMICAL IN THE EARLY 1970's
Source: Reference 1, revised per VSI.

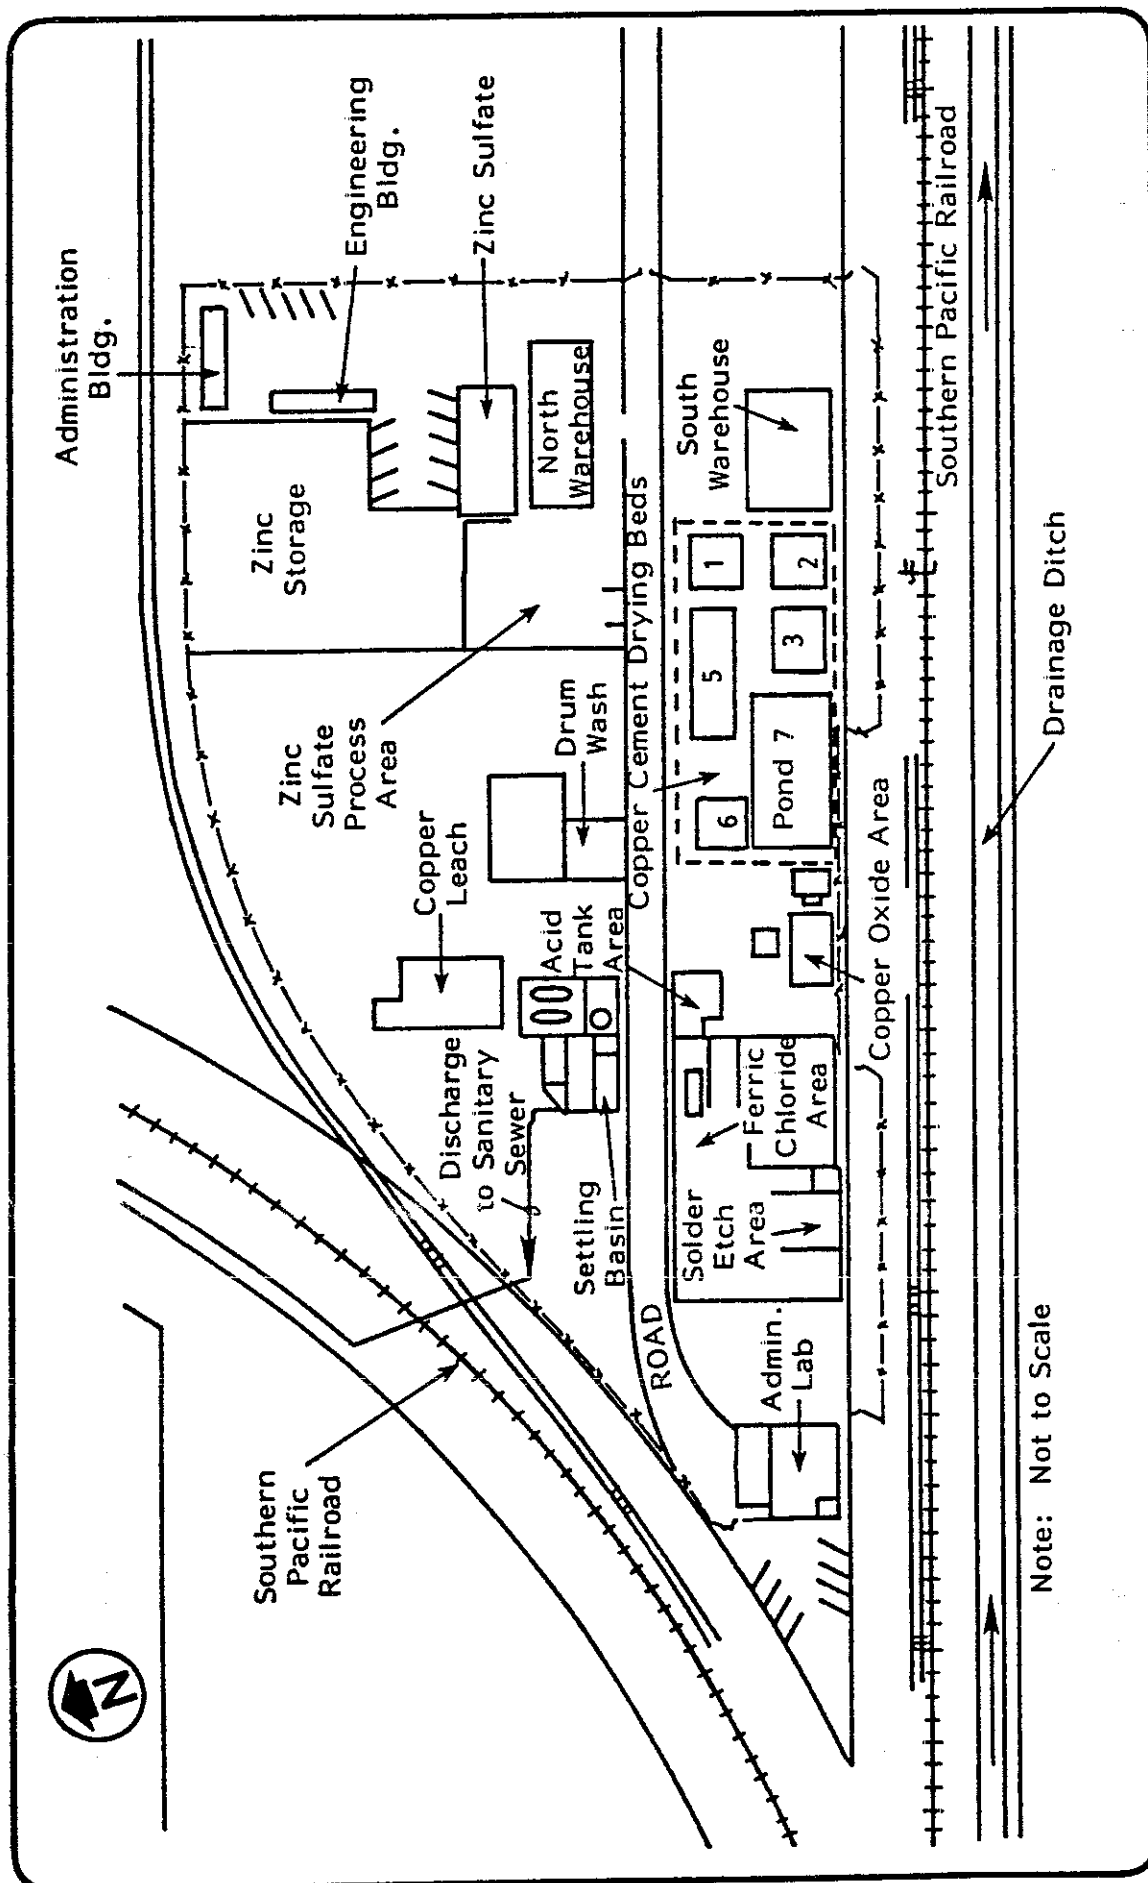
Figure 3

PLOT PLAN OF SOUTHERN CALIFORNIA CHEMICAL, CIRCA 1977
